# **INSPECTION REPORT**

**6789 Locust St  
Philadelphia PA 19100  
PREPARED BY  
INSPECTIONS UNLIMITED INC.**

August 24, 2010

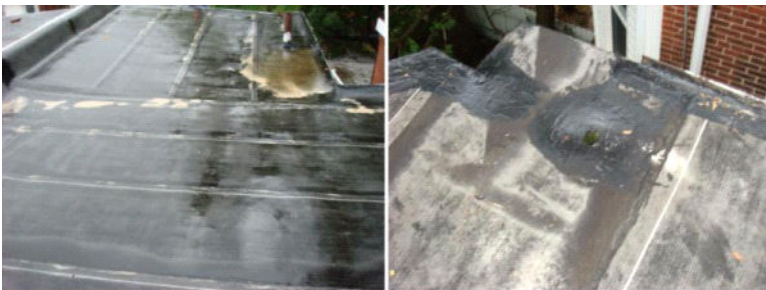
It was observed that the roof in various areas is holding water. In time this will cause this area of the roof to prematurely deteriorate and fail. Repairs should be made accordingly by a licensed roofing contractor.

**ESTIMATED COST \$800.00-900.00 At this time it is necessary that the single ply-membrane roof be coated with a "silver" coating or other suitable material that is compatible with the installed roofing. This will extend the life of the roof and reflect the sun rays, reducing heat build up, in addition all seams etc. must be properly coated. If replacement of the flashings is necessary an additional cost will be incurred. If during the repair/coating process any additional damage or conditions are found and added cost for repairs and/or replacement maybe incurred. In addition provide the minimum requirement of a two year guarantee by a licensed roofer.**

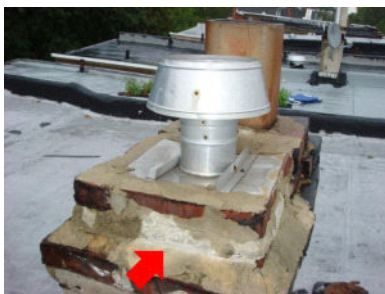
There is cap installed on the metal liner for the masonry chimney, because of this the liner can not be visible inspected from above. If access is possible from the inside it will be limited due to the lack of light and the installed cap. The installation of a cap will help reduce water infiltration and the chance of birds etc from entering the chimney. If you are concerned about the condition of the liner an inspection by a chimney sweep, including removal of the cap and a cleaning should be arranged. A cap must always be in place or deterioration of the metal liner will occur.

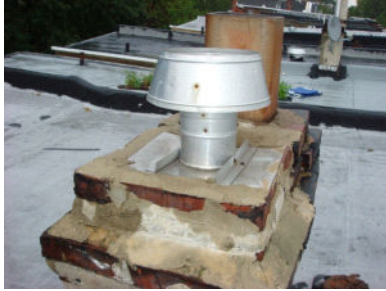
There is what appears to be an abandoned chimney present in the rear, this should be sealed and stabilized. Failure to make these repairs will lead to water infiltration and result in possible additional damage.

**ESTIMATED COST \$250.00-300.00 each Seal and stabilize the abandoned chimney. If hidden damage is found an added cost will be incurred.**

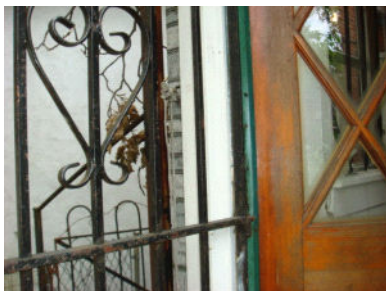
The general condition of the painting is fair to poor and in need of repairs and painting at this time. All exterior surfaces require ongoing maintenance and painting. Considering the age of the property it maybe assumed that lead base paint was used at sometime in the past. Care should be used when working on any surface that has or may have had lead base paint installed. For additional information you can access <http://www.leadsafeusa.com/>. There are signs of deferred maintenance. It is recommended that a full survey of all exterior painted surfaces be performed by a qualified contractor with an estimated for painting and repairs if necessary being provided.

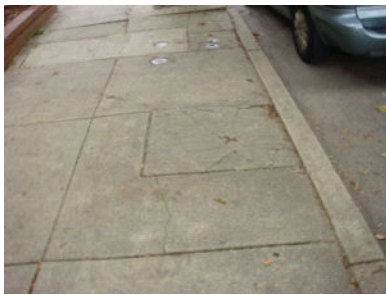
The exterior steps are concrete and are in fair condition at this time, but as with all exterior steps ongoing maintenance and repair as necessary to maintain a safe area.

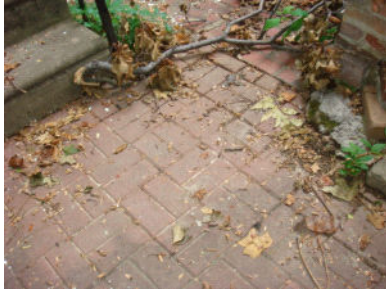
The wrought iron fence is in fair condition, all fences will require repairs with age. All fences require ongoing maintenance along with repairs. This information is for your general knowledge, but is not generally considered to be a part of the inspection.

The trees and/or bushes adjacent to the building are hitting and rubbing against the building. This will in time cause wear and damage the building in any place where there is contact. We recommended that they be trimmed so as not to have direct contact with the building. This will also allow for an inspection of any hidden areas for possible damage. In areas where access was impeded no visual inspection was performed at this time.

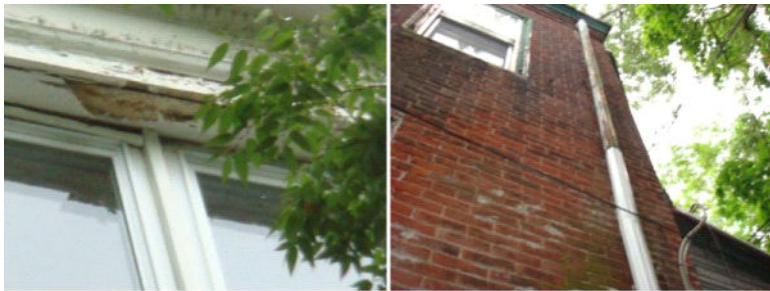
Trees have been known to caused the problems with the sidewalk and or driveways. In addition they may also have an adverse effect on the plumbing system. Trees of this type and size have been known to send roots into drains and cause blockage and or failure. This condition can not be determined from a visual inspection. If you are concerned it is recommended that the current owner be questioned about past and/or current problems pertaining to the drain system and the tree. **If you are concerned about possible hidden problems with the drains it is recommended that you consider video inspection of the drains, this will allow for a more detailed inspection of the drainage and water system.**

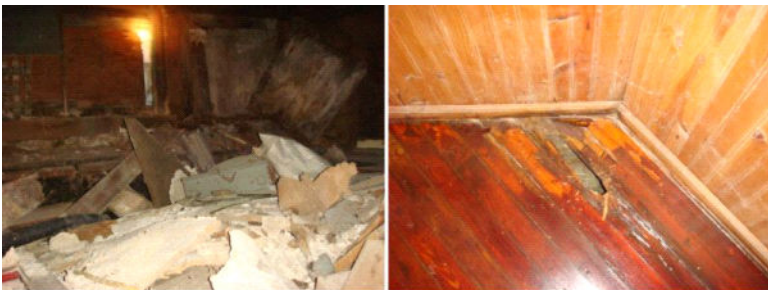
There are visible failed or compromised joist present that were *improperly repaired* in the past. The joist are located in the basement.

**ESTIMATED COST \$250.00-350.00 each The improperly repaired failed or compromised joists must be "sistered" with joist of the same or greater size then the failed member. They must be mechanically attached and BOLTED with nuts and washers to the failed or compromised joist. When possible this should be from end to end, but if not possible due to conditions, it must be a minimum 5' either side of the failure and/or to a bearing wall. This can be done with proper sized and spaced through bolts with nuts and washers. The bolts should be a set at a minimum of 16" o.c (on center) and be ½" in diameter properly spaced and staggered.**

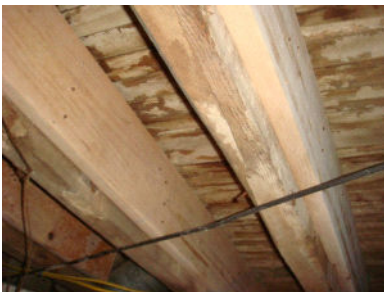
The basement stairwell is improperly supported, by current standards, although no excessive movement was observed it is our strong recommendation that the area be monitored and if necessary repaired in the future. The use of mortise and tendon joints has not been used in construction for many years. This type of joint has a tendency to fail point where the joist is set into the header. Repairs can be made in numerous ways, ranging from installing a bearing wall to installing joist hangers.

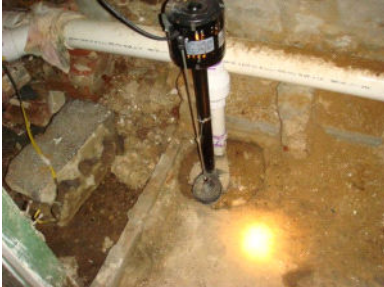
The sump pump discharges into the sanitary system. This is not permitted in most areas because this method of discharge poses an additional cost and burden on the sanitary system, all discharges should be to the outside placed a minimum of 3' and down grade from the building.

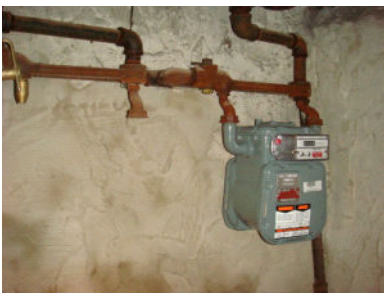
The visible gas piping shows of sagging, it is important that all pipes be properly supported using metal straps designed and approved to the purpose. Otherwise the system shows no signs of excessive deterioration inconsistent with the age of the building.

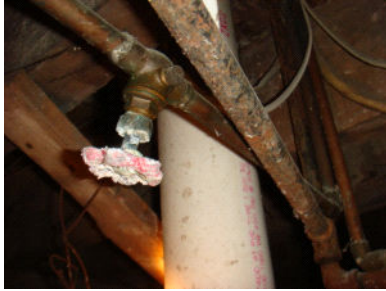
There is no cap or plug for the disconnected or terminated gas line in the, basement. Repairs are necessary to prevent possible future leaks and related damage.

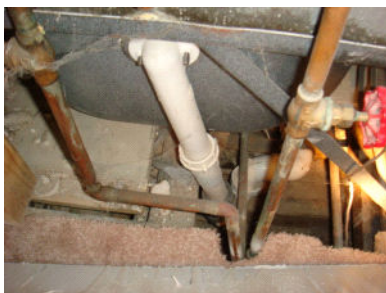
The faucets and diverters are in fair condition for there age and replacement should be budgeted for in the near future.

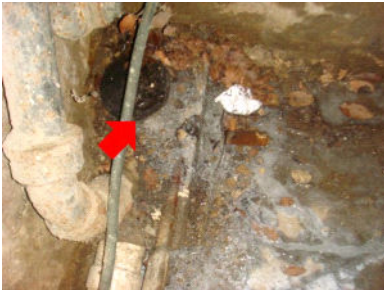
The cast iron drains in the basement were not properly supported. All drains must be properly supported at 5' intervals.

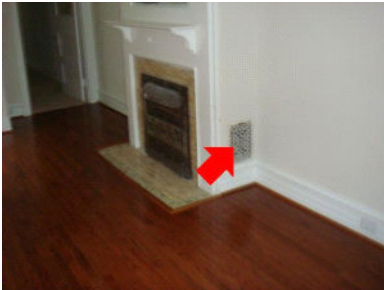
There is notable air lose in the area of the ducts. Although not a major concern the efficiency of the heating and if present cooling system will be diminished. It is recommended that all leaks be sealed with a proper material.

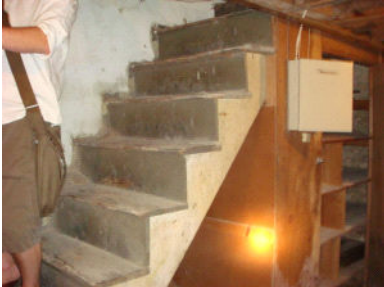
There is no railing for the lower steps on the first floor and required for safety.
