# **INSPECTION REPORT**

**6789 Locust St  
Philadelphia PA 19100  
PREPARED BY  
INSPECTIONS UNLIMITED INC.**

Re: 6789 Locust St  
Philadelphia PA 19100

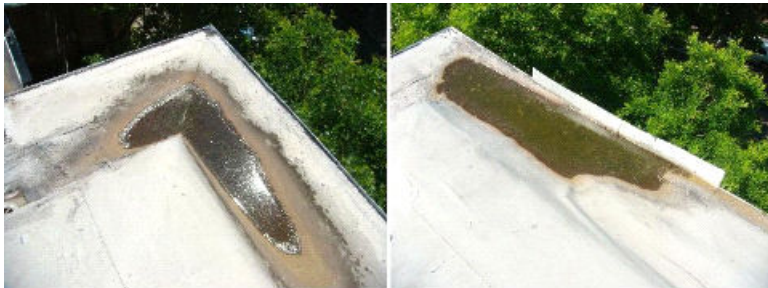
There is a large fixed skylight present on the roof. This unit has been covered with roofing material. When this is done, the body of the skylight can not be inspected. It should be assumed that ongoing repairs have been performed to the area in the past. Additional repairs and maintenance will be necessary in the future.

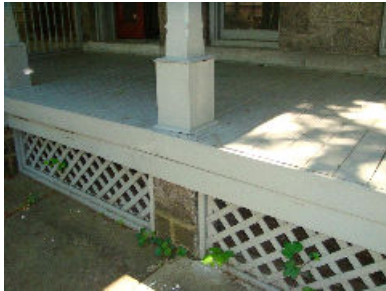
Because of the conditions present access was not possible and the area was not visible inspected. Removal of installed lattice would be necessary and is beyond the standards of our inspection.

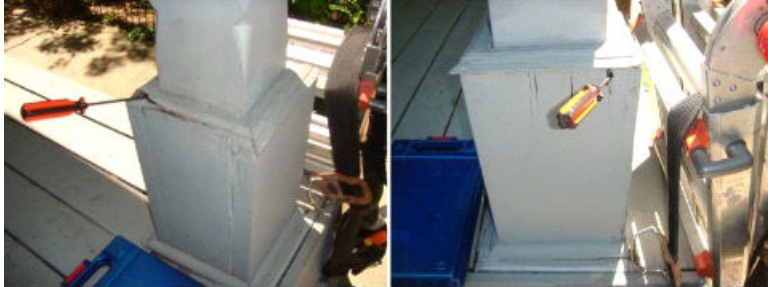
It was observed that the front right masonry pier was tilted more than is acceptable. While it is possible that this has been like this for many years, replacement is necessary with a proper footing. This must be installed by a licensed and qualified contractor.

ESTIMATED COST \$1000.00-1400.00 Replace the masonry pier in the front right corner of the porch as necessary. When replace it is important that a proper footing be installed. All work must be performed by a licensed and qualified contractor. At the time of repairs by the chimney contractor it is recommended that it be determined if the chimney is capable of safely venting two boilers and a 75 gallon water heater. If additional repairs are needed, there will be an additional cost.

**ESTIMATED COST \$1000.00-1400.00 Replace the masonry pier in the front right corner of the porch as necessary. When replace it is important that a proper footing be installed. All work must be performed by a licensed and qualified contractor. At the time of repairs by the chimney contractor it is recommended that it be determined if the chimney is capable of safely venting two boilers and a 75 gallon water heater. If additional repairs are needed, there will be an additional cost.**

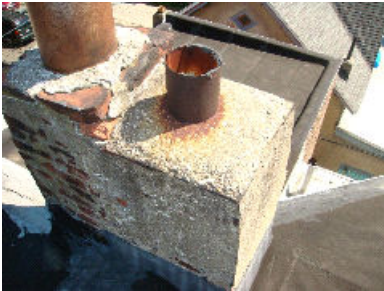
There are multiple abandoned chimneys present on the roof These should be sealed and stabilized. Failure to make these repairs will lead to water infiltration and result in possible additional damage.

**ESTIMATED COST \$150.00-200.00 each Seal and stabilize the abandoned chimneys. If hidden damage is found an added cost will be incurred. Before the chimneys are sealed it must be made sure that they are not being used.**

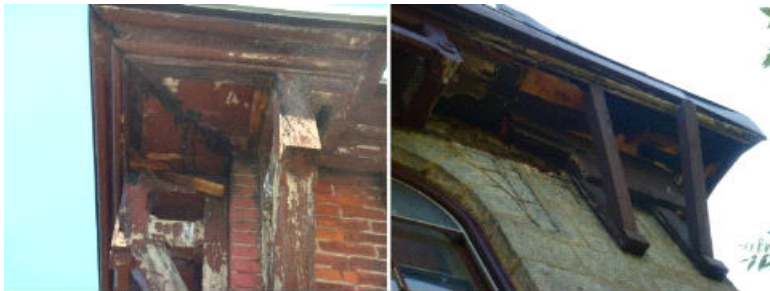
Along the lower roof edge of one of the roof it was noted that the wood was rotted and damaged and in need of replacement at this time. This beam is the support under the roof edge.

ESTIMATED COST \$500.00-600.00 Replace the rotted and damaged wood beam under the roof edge as necessary. It is possible that there is hidden damage present that maybe found after repairs are started. If found an added cost of repairs or replacement will be incurred.

**ESTIMATED COST \$500.00-600.00 Replace the rotted and damaged wood beam under the roof edge as necessary. It is possible that there is hidden damage present that maybe found after repairs are started. If found an added cost of repairs or replacement will be incurred.**

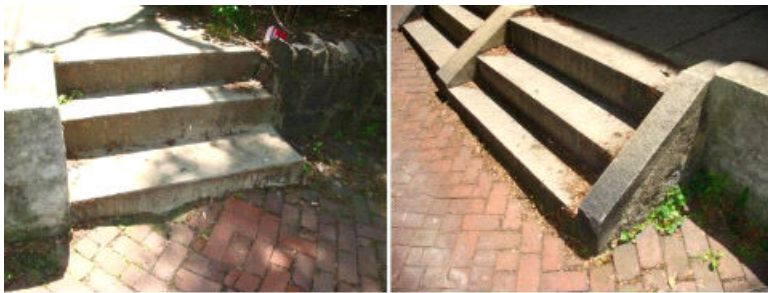
Railings are necessary for safety when there are (3) three or more risers. This condition exist for the front steps

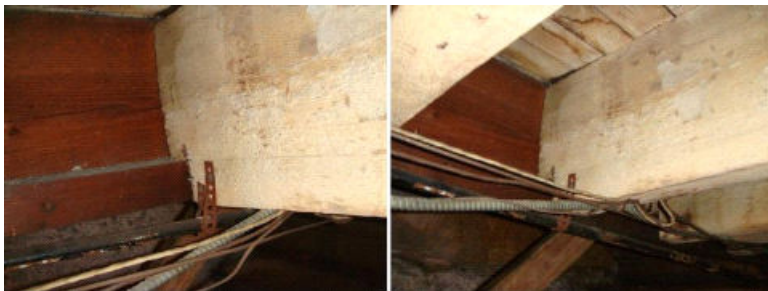
**There was what appears to be termite activity in the basement. Its determination as to whether its active of not can only be determined by a licensed and certified individual, neither this inspector or any inspector from this company, Inspections Unlimited Inc. is licensed or certified as a WDI (Wood Destroying Insects) inspector. This should not to be considered a termite inspection which must be performed by a certified individual, nor is this to be considered a list of all infested areas. A complete inspection by a state certified individual is required. Termite infestation and damage can be very extensive, is often hidden, and cannot be found by a visual inspection. As per the American Society of Home Inspectors standards of practice, our inspection is of visual and accessible areas only.**

**ESTIMATED COST \$250.00-400.00 Have this building exterminated by a qualified licensed contractor as necessary.**

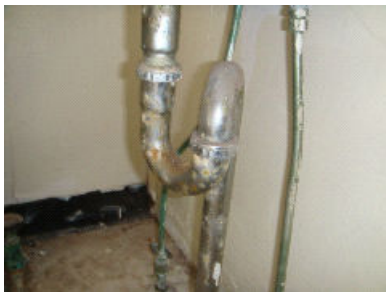
The bathroom tub and kitchen sink are draining slowly and will require possible cleaning and or repairs. It is assumed that no excavation, opening of walls or ceilings etc. will be necessary for these repairs.

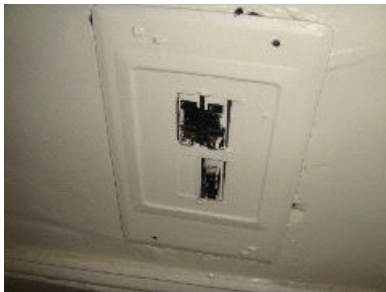
There are missing circuit breaker blanks in the electrical panels in various units. All openings must be properly sealed.

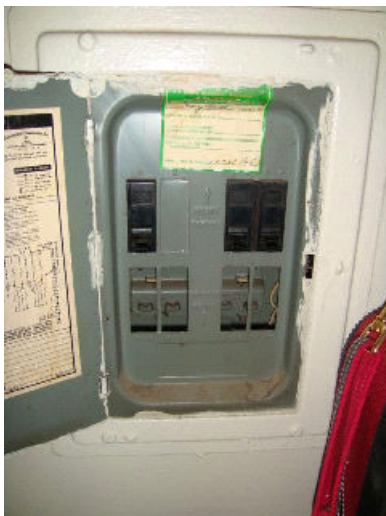
The sub panels throughout the building are improperly installed as per today's standards. All sub panels must consist of four (4) wires and have the neutral and ground isolated. In a normal panel the neutral and ground are both connected to the same point of termination.
