INSPECTION REPORT

**2100 Williams Ave
Philadelphia PA 19100**

**PREPARED BY
INSPECTIONS UNLIMITED INC.**

February 27, 2007

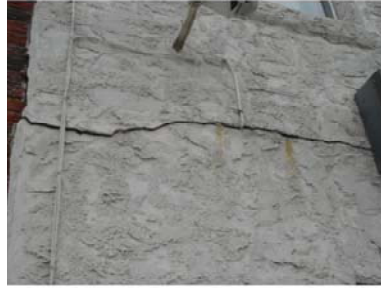
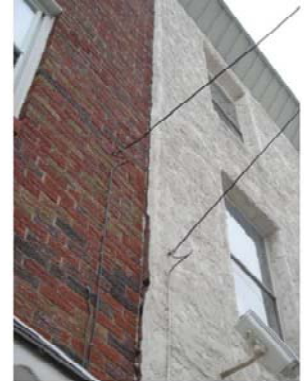
There are area where the stucco has failed and requires replacement at this time. This appears to be common to the majority of the areas. It also appears the stucco and man made stone was poorly installed and the presents of wire lath is questionable. But at a minimum the wire lath, if present was not properly secured to the structure. In addition no visible provisions were made for the drainage of water that will migrate behind the stucco.

ESTIMATED COST The exterior requires replacement of the stucco at this time. The estimated cost for repairs is \$11.00-14.00 per square foot for small areas, but if all areas are repaired/replaced an estimated cost of of \$9.00-12.00 per square foot can be used. In addition the cost for removal must be considered along with any possible hidden damage.

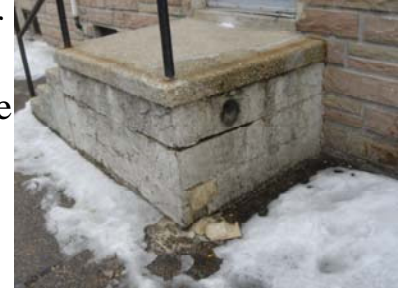
The exterior steps are concrete and marble and are in fair to poor condition at this time, but as with all exterior steps ongoing maintenance and repair as necessary to maintain a safe area. Care should be taken that water does not collect in the low areas and freeze during the cold weather, particularly on the marble steps. In addition the ramp should be monitored and repaired on an as needed basis.

Some deterioration of the base to the side steps was noted and will require repairs in the next 1-2 years. As previously noted when the stucco is replaced these too should be repaired.

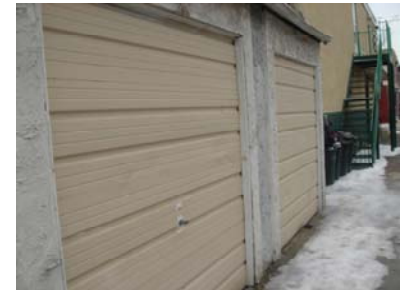
There is a two car attached garage present. The garage door was locked. No inspection of the interior nor the operation of the door was performed. Once access is possible it is recommended that an inspection of the interior and the operation of the garage be performed.

ESTIMATED COST \$ Perform a complete inspection of the garage interior, door and any related components once access to the garage is possible, if defects are found an added cost for repairs will be incurred. As per information presented the interiors are in poor condition and complete replacement maybe more cost effective than repairs.

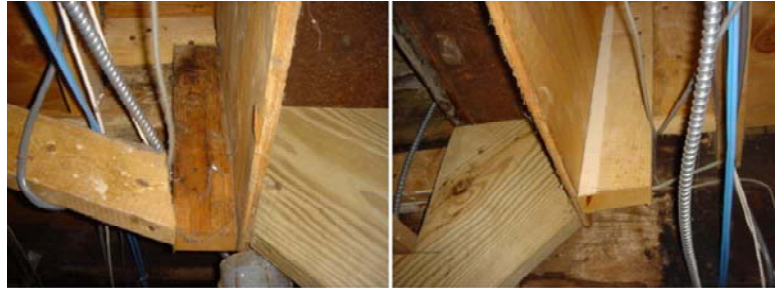
The steps to the basement are in poor supported and require repairs at this time. In is important that all steps be properly secured and supported. The point of support at the top must be to a properly installed structural member capable of providing adequate bearing for the steps and any weight on these steps.

ESTIMATED COST \$150.00-250.00 Properly secure and support the basement steps to the structure, providing proper and adequate support at all points of bearing.

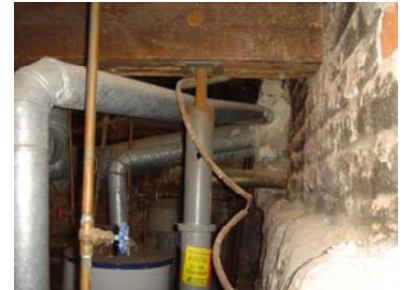
There is a temporary post jack installed at various locations in the basement, that has become a permanent installation. It is recommended that this be replaced with a permanent jack or post.

ESTIMATED COST \$150.00-250.00 each Replace the multiple temporary post jack at location. The use of a permanent post jack or 6 x 6 beam mechanically secured to the joist and floor are recommended. If a footing is necessary, as required, an additional cost will be incurred.

The permanent supports installed should be properly secured to the beam and where necessary a proper footing installed.

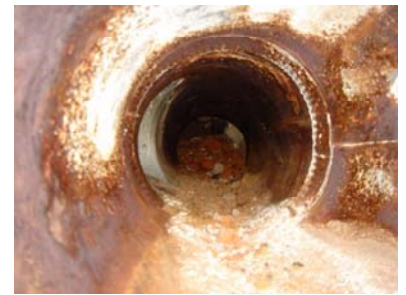
From a visual inspection from the roof and/or the basement, a liner is needed at this time to prevent dangerous gases, carbon monoxide, from entering the house. There are various methods of lining a chimney. A contractor qualified and who specializes in this should be consulted. The cost will vary depending on the method and on site conditions.

ESTIMATED COST \$1500.00-1800.00 Install a flue liner for the existing chimney as necessary. Sealing and/or repairs to the structure of the chimney should be made on an as needed basis.

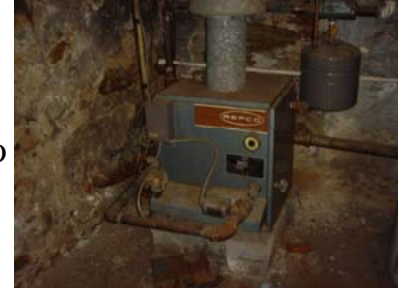
The average life expectancy of this type of boiler is 40-45 years with proper maintenance. All systems require periodic maintenance along with repairs during there life. Failure to provide these items will shorten the life of the system and lead to premature failure along with higher operating cost. The heater appears to be 25-30 years old and not in use at this time.

The pilot light was out to the boiler and the gas off, for safety and insurance reasons we do not light a pilot if out at the time of the inspection. Lighting and servicing and repairs on an as needed basis are necessary to the heater.

ESTIMATED COST \$150.00-200.00 Light and service and the hot water boiler and determine the cause of the problem or if the unit is usable, for safety and insurance reasons we do not light a pilot if out at the time of the inspection. The cost of repairs or replacement will be additional. In addition all parts of the system should be inspected for proper operation. It was also noted there is signs of rust on the side panels possible the result of leakage which would require a new boiler.

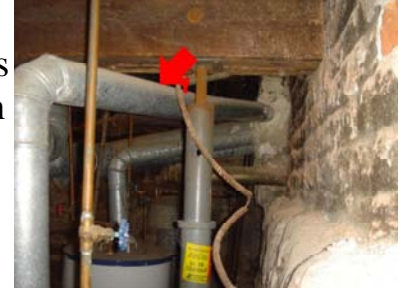
The water heater is vented to the chimney through a metal stack. As installed the stack is loose and not properly secured. All vents should be mechanically secured at all joints and installed with an upward pitch of 1/4" per foot to the chimney. Failure to properly secure and the vent can lead to failure other serious defects.

ESTIMATED COST \$50.00-75.00 Properly secure the vent from the water heater to the chimney. All vents should be mechanically secured at all joints and installed with an upward pitch of 1/4" per foot to the chimney. All vent piping must be of an approved material for the type fuel being used.

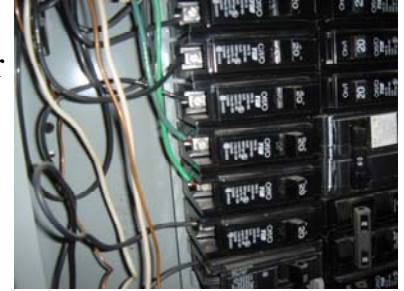
There are "green" wires connected to circuit breakers in the panel. The use of "green" wire is limited to ground wires only and therefore incorrect. This is also the sign that a non professional performed work in the building.

ESTIMATED COST \$75.00-125.00 Have a licensed electrician correct the use of a "green" wire connected to a circuit breaker. If any rewiring outside of the panel is required an added cost will be incurred.

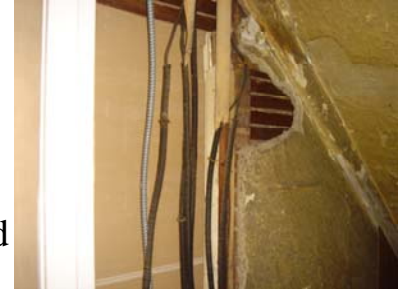
In some locations active (live) knob and tube wiring is present. Knob and tube wiring is extremely old and most likely the original wiring installed at the time of the original construction or the adding of electricity buildings built before the advent of electricity. This type of wiring was common until the about 1940. The wiring tends to become very brittle because of its age and in some cases the improper use over the years. When and where possible, all knob and tube wiring should be replaced with Romex (non metallic cable) or MC- Metal-Clad cable and never should it be added to or modified in any manner, except to be replaced.

It is our recommendation that you budget for replacement of all knob and tube wiring. But if you plan to continue using these circuits, they should be used only for light use and not for heavy appliances such as air conditioners, kitchen appliances, dryers etc. When any renovations are done all electric should be upgraded and the knob and tube wiring replaced.

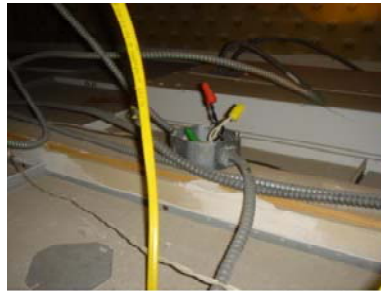
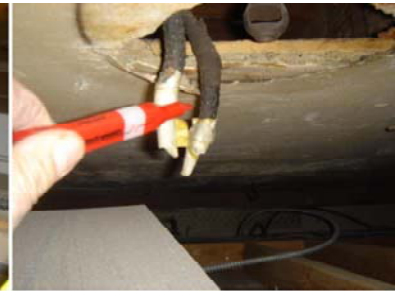
Correct the open splice in the middle of the basement and elsewhere as needed.

ESTIMATED COST \$75.00-125.00 each Correct the open splices in all areas of the basement and elsewhere, all splices must be enclosed in an enclosure designed for this purpose.

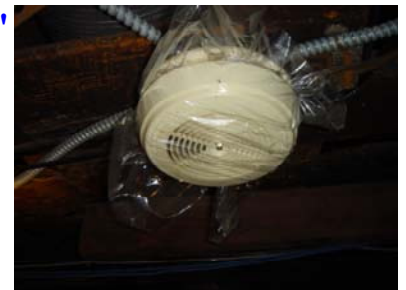
The smoke detector in the basement is covered with "plastic" for an unknown reason and will not work. This and all units must be in proper working condition.
