INSPECTION REPORT

**6789 Newtown Road
Holland PA 18900
PREPARED BY
INSPECTIONS UNLIMITED INC.**

September 3, 2010

On September 2, 2010, I inspected the above referenced property, as per your request. The home is a 2± year old building. The temperature was approximately 86± degrees and the weather was clear. The following is a summary of the conditions found from a visual inspection at that time.

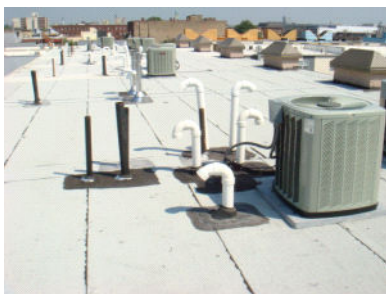
It was observed in the front of the roof and one of the neighbors roof that the capping had been patched, while all the other roof on the row were not. This is typically an indication of a past leak that may have been repaired. It is recommended that the builder be questioned as to reason for the patched area.

TO BE CORRECTED BY THE BUILDER Determine the reason for the recent roof repair in the front of the roof and whether or not there was a leak.

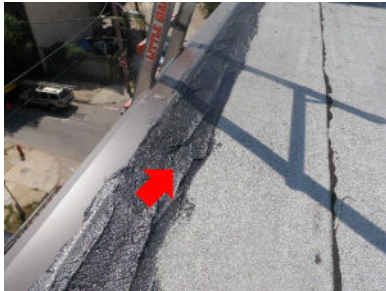
There is no parapet wall present above the roof line between the adjacent buildings. Today and for many years it has been required that a firewall be erected between adjacent properties from the foundation to above the roof line, unless stated in the approved plans that this is acceptable. The purpose of is to reduce the chances of a fire spreading to adjacent properties. *In addition, when the wall protrudes above the roof line it reduces the chance of a leak from adjacent properties migrating from one area to another. Erecting a firewall between existing buildings is not practical and can be prohibitive in cost.*

TO BE CORRECTED BY THE BUILDER Confirm the reason for the lack of a parapet wall above the roof between the adjacent buildings. This should be noted in the approved plans.

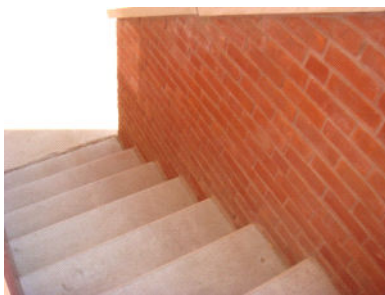
Railings are necessary for safety when there are (3) three or more risers. This condition exist for the, front steps,

TO BE CORRECTED BY BUILDER Install proper railings for all exterior steps, having (3) three or more risers. All railings should be securely installed and placed 30"-38" above the tread, with the grippable portion being 1 1/4" to 2". Where conditions exist that the steps are wider then 5' a railing is required on each side or if the open side has a drop off of greater then 24" a second rail maybe required. In addition normal maintenance to any existing railings should be exercised to maintain a safe walk area.

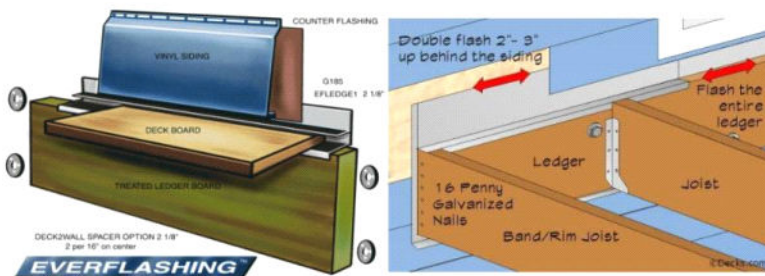
From our visual inspection it does not appear the proper flashings are installed between the deck and the building as now required. Proper flashing is one of the most important precautions in deck and or steps construction. Keeping water out from behind your deck frame and siding is very important. If water were to penetrate, it would not only cause rot damage but it may rust the attachment hardware and cause structural failure. There have been many stories over the past years of decks falling off a house under a party of people. Water penetration is one major reason for some of these events.

TO BE CORRECTED BY THE BUILDER Have additional inspection consisting of thermal imaging/ thermography performed to determine the presents and or extent of damage caused by improper or missing flashings/detailing. Invasive inspections will be additional and are destructive in nature and will require permission.

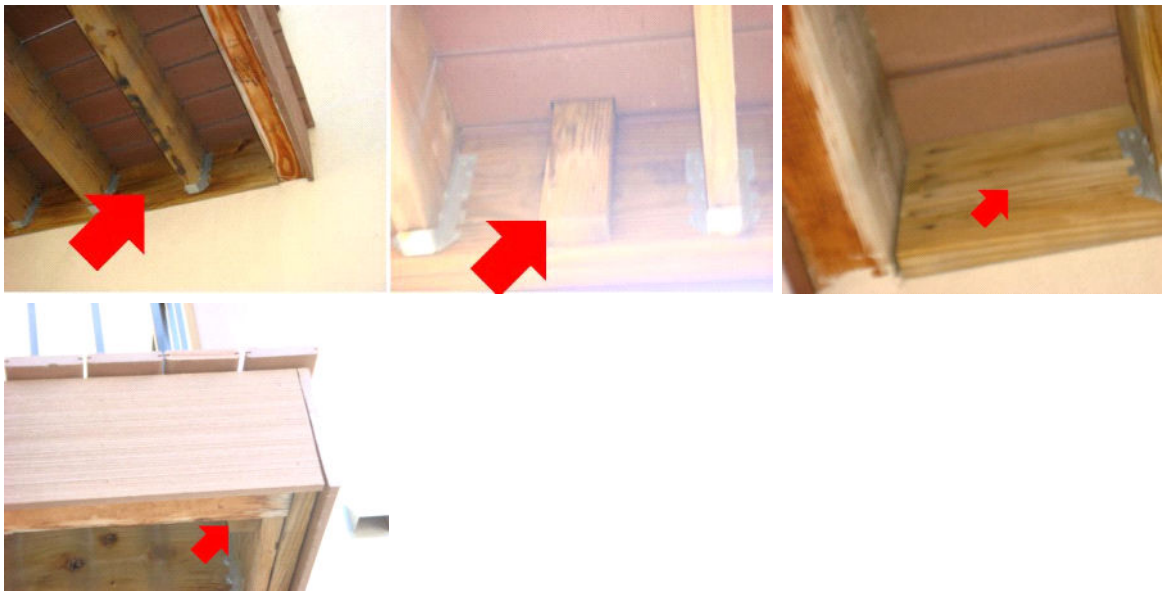
It was noted that the deck structure below was only nailed together. Nails have a tendency to pull apart over time and are not approved for decks. It is required that the posts, beams and headers be bolted together with a minimum of 1/2" through bolts or manufactured connectors designed for the purpose.

(2) per joint staggered, for all the structural members of the deck or install manufactured connectors designed for the purpose. This includes but is not limited to the posts, beams, steps and headers. For points of attachment to the building when not possible properly sized lag bolts are often used. These must be pre drilled and of a length adequate to penetrate the header and through to the interior structure. Failure to properly attach the various members may lead to failure of the structure.

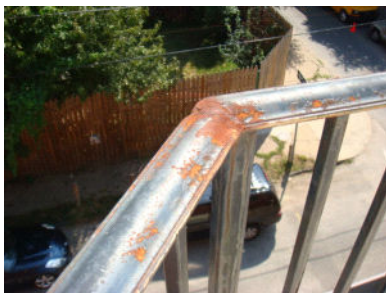
There is a balcony present on the fourth floor. It was observed that the railing for this balcony was rusting. This must be replaced with a new railing.

TO BE CORRECTED BY THE BUILDER: Replace the rusting railing on the balcony as necessary.

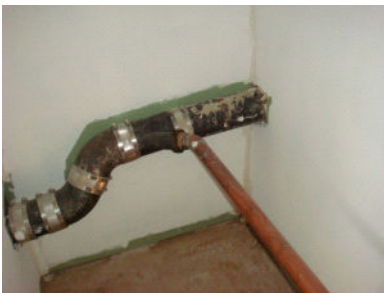
The sump pump discharges into the sanitary system. This is not permitted in most areas because this method of discharge poses an additional cost and burden on the sanitary system, all discharges should be to the outside placed a minimum of 3' and down grade from the building.

TO BE CORRECTED BY BUILDER Remove the sump pump discharge from the sanitary drain system and properly seal all openings. The proper discharge of the sump pump should be placed at a minimum of 3' and down grade from the building.

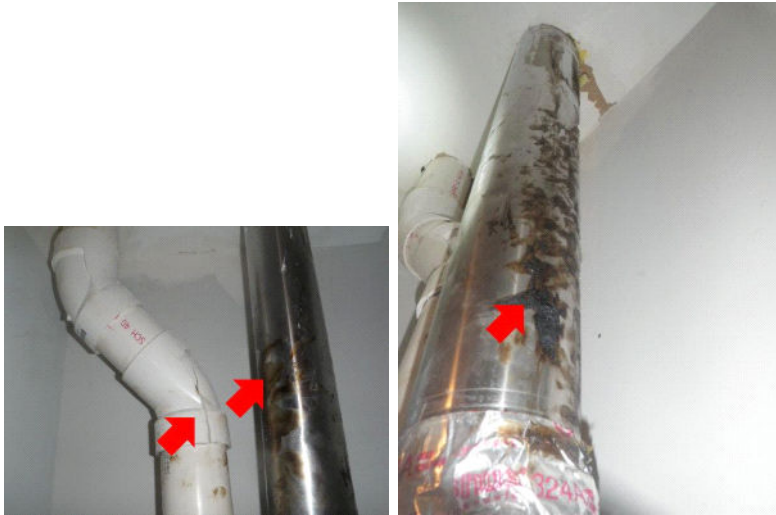
The intake and discharge pipes for the tankless water heater were poorly installed. The PVC intake vent pipe is cracked and broken inside and the stainless steel vent pipe was covered in what appears to be roofing cement. This does not appear to be a professional installation and must be corrected by a licensed and qualified contractor.

TO BE CORRECTED BY BUILDER : Replace the cracked PVC intake pipe for the tankless water heater and removed the roofing cement from the exhaust pipe as necessary.

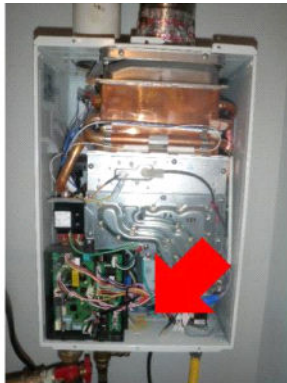
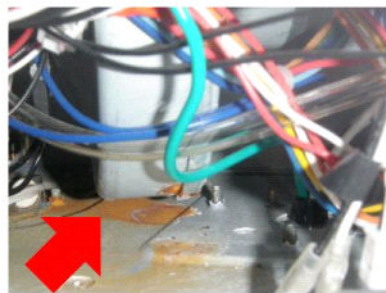
Inside the water heater it was observed that there is a small condensation leak present, This will in time rust the cabinet of the tankless water heater. This must be repaired accordingly.

TO BE CORRECTED BY THE BUILDER : Repair the condensation leak that was observed inside the tankless water heater.

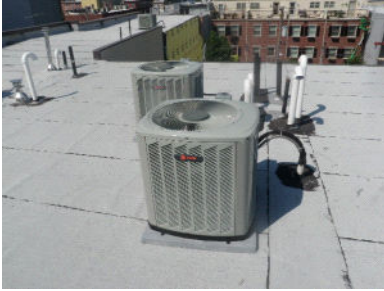
The unit is level and free of obstructions. It is recommended that a minimum of 3' clearance be maintained around all condensing units to allow for service and proper air flow. When a unit as in this case is installed on the roof an added cost for replacement will be incurred. When the roof was mounted for inspection it was discovered that the neighbors air conditions compressor was located on this roof. The neighbors compressor must be relocated onto its own roof as necessary.

TO BE CORRECTED BY THE BUILDER: Relocated the neighbors air conditioner compressor onto its own roof as necessary.

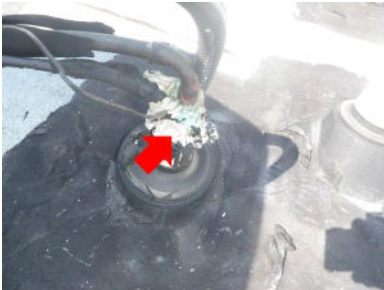
It was also noted that the pipes in which the air conditioner pipes and wires were fed through were poorly sealed and require repairs.
