INSPECTION REPORT

**1234 Baker Ave
Philadelphia PA 19100
PREPARED BY
INSPECTIONS UNLIMITED INC.**

Re: 1234 Baker Ave
Philadelphia PA 19100

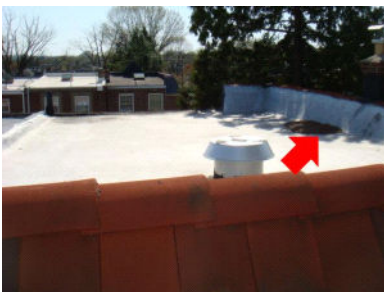
The debris on the roof are from the trees and as noted the trees should be trimmed. Failure to keep the roof clear will result in deterioration and may lead to clogged drains and the resulting leaks.

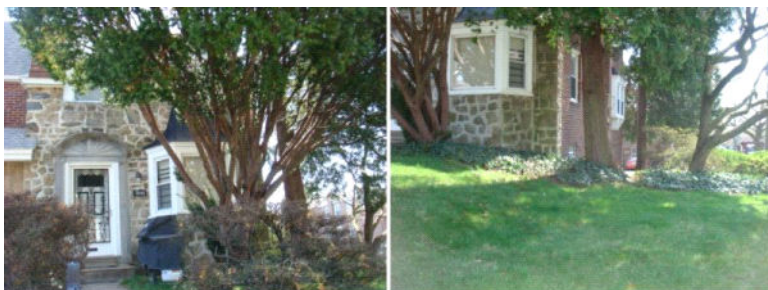
The large tree present which may also have an adverse effect on the plumbing system. Trees of this type and size have been known to send roots into drains and cause blockage and or failure. This condition can not be determined from a visual inspection. If you are concerned it is recommended that the current owner be questioned about past and/or current problems pertaining to the drain system and the tree. If you are concerned about possible hidden problems with the drains it is recommended that you consider video inspection of the drains, this will allow for a more detailed inspection of the drainage and water system.

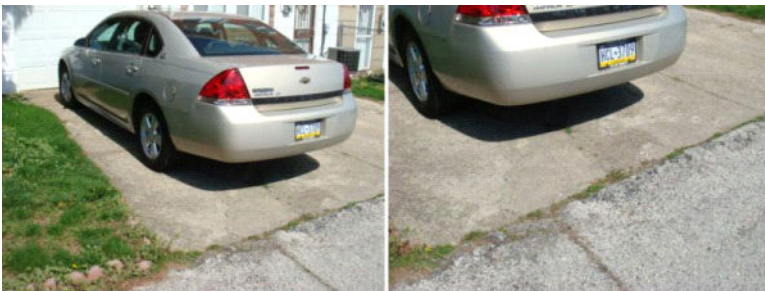
The driveway is, concrete and in fair to poor condition at this time and will require repairs in the next 1-2 years. Most of the area was covered with a car, but signs of normal deterioration were noted.

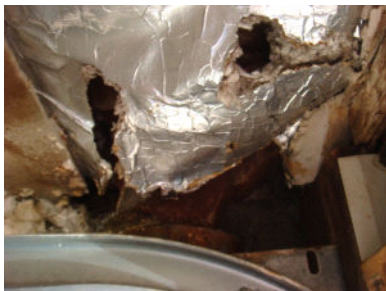
There are minor holes in the ceiling of the garage. All holes must be properly sealed to maintain the fire integrity of the garage. The use of a fire rated material such as cement, stucco, 5/8" fire code dry wall or an approved equivalent material for the ceiling or walls of the garage. If large areas require repairs the use of 5/8" fire code dry wall is recommended . THE USE OF EXPANDABLE FOAM TYPE MATERIALS USED FOR REDUCING DRAFTS ETC. IS NOT ACCEPTABLE. THIS IS NOT A FIRE RATED MATERIAL.

ESTIMATED COST \$125.00-175.00 Repairs are necessary to correct the minor holes in the garage walls and/or ceilings. The use of a fire rated material such as cement, stucco, 5/8" fire code dry wall or an approved equivalent material for the ceiling or walls of the garage. If large areas require repairs the use of 5/8" fire code dry wall is recommended . THE USE OF EXPANDABLE FOAM TYPE MATERIALS USED FOR REDUCING DRAFTS ETC. IS NOT ACCEPTABLE. THIS IS NOT A FIRE RATED MATERIAL.

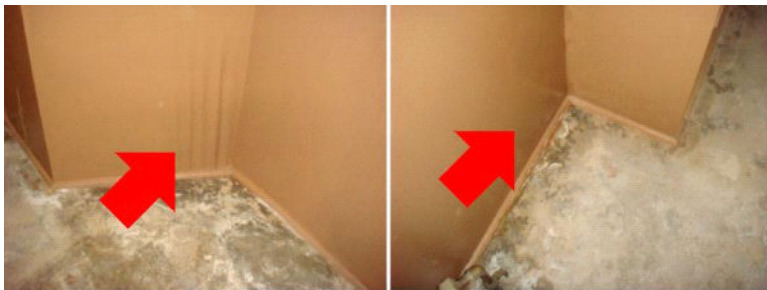
If you are concerned about the mold present a microbial investigation of the affected areas, by a certified company is recommended. This is necessary to assess the impact of the mold on those areas and in some instance the building. The results of this investigation and test should be used to estimated the cost of remediation All removal of mold, damaged walls, ceilings, carpeting etc. must be performed by a mold abatement contractor. Failure to properly remove the mold and protect the workers may result in additional damage an injury. The cost of the microbial investigation will depend on the size of the areas to be inspected. This can range from \$350.00-450.00 to several thousand dollars.

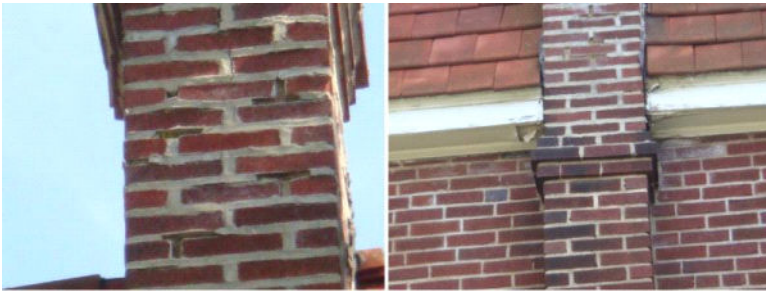
Considering the age and location of the chimney, on an outside wall with three exposed surfaces, a chimney liner maybe required when a new heater is installed or possible before. New safety standards recommend a liner for chimney installed in this manner to reduce the chance of failure of older type chimneys. Signs of past repairs and current deterioration of

the pointing was noted. Future repairs and a possible liner should be considered as the normal aging of the system continues.

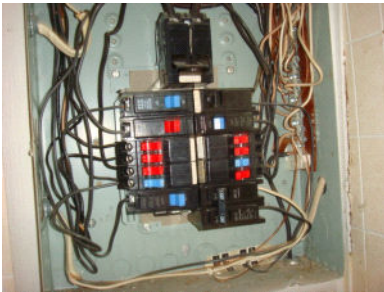
The electrical service terminates in the laundry room into a circuit breaker panel. The cover and/or covers of the electrical panel were removed and the interior was visibly inspected for signs of arcing or over heated circuits, no visible signs of damage were observed. It was observed inside the circuit breaker panel that there are wires present with the outer

ESTIMATED COST \$75.00-100.00 Have a licensed electrician remove the outer insulation on the wires in the panel as necessary.

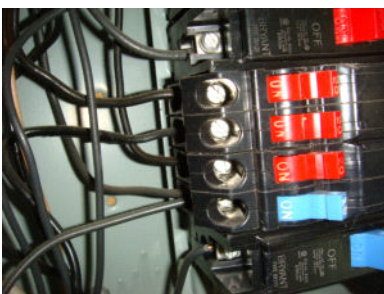
In the panel, circuits are present with more than one wire under a screw. These wires should be separated onto separate circuits properly sized overload protective devices. This will assure the proper use and distribution of power. This is in addition to reducing the chance of unequal torque on the separate wires, which can cause overheating and potential fire hazards.

ESTIMATED COST \$100.00-150.00 Correct all double tapped circuits as required. If an additional panel is necessary to facilitate the repairs added cost will be incurred.

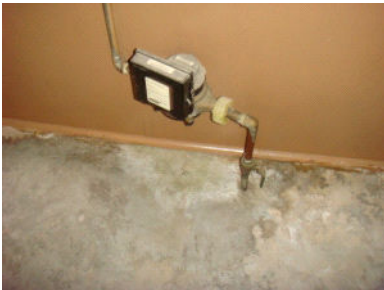
The water meter does not have a properly installed jumper for the electrical system. This should be installed so that if at any time the water meter is removed the electrical system will still be properly grounded.
