INSPECTION REPORT

**6789 Marlton Ave
Bala Cynwyd PA 19000
PREPARED BY
INSPECTIONS UNLIMITED INC.**

June 25, 2010

On April 10, 2010, I inspected the above referenced property, as per your request. The home is a 110 ± year old building. The temperature was approximately 75± degrees and the weather was overcast. The following is a summary of the conditions found from a visual inspection at that time.

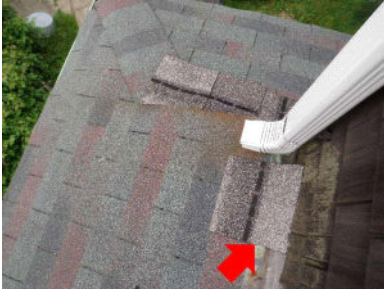
There are some shingles on the roof that are loose and in need of repairs at this time.

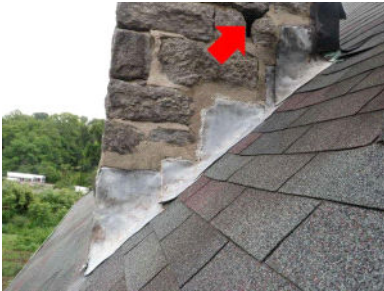
In some areas flashings were not visible. Typically a portion of the flashings are exposed above the shingles then installed to a wall. Without flashings leaks are likely. Since leaks were not visible inside, these areas should be monitored and if necessary installed.

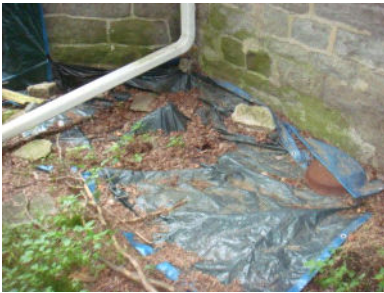
On the left side of the house there is a aluminum downspout that is loose and not properly supported. This must be repaired as necessary.

ESTIMATED COST \$150.00-250.00 Repair as necessary the gutter and downspout on the left side of the house. If replacement is necessary there will be an additional cost.

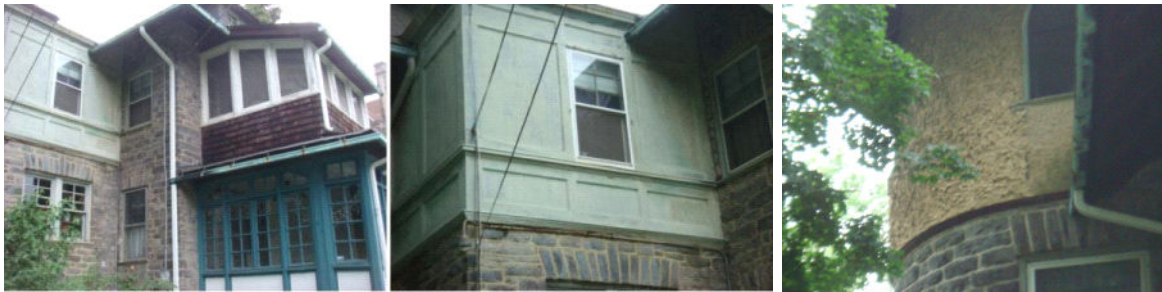
Proper flashing detailing and installation is a critical component of a waterproofing system. This applies to roofs, basements, crawlspaces, exterior cladding, windows, doors etc. Flashings are applied at intersections of horizontal and vertical planes, points of penetration to provide waterproofing protection at these vulnerable junctures. These areas are the most vulnerable points of the entire system. Many reports of failures or leaks can be traced to improper flashing design, detailing or application. Successful flashing system design and installation is required at all points of terminations. It is essential that the flashing system be designed in compliance with the material manufacturers requirements for materials and application methods being used.

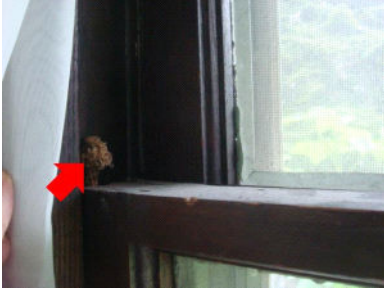
Repair or replace the failed window counter balance on the second floor.

ESTIMATED COST \$100.00-125.00 each Repair or replace the failed window counter balance for the listed windows. When replacing the counter balances they should always be replaced as a set.

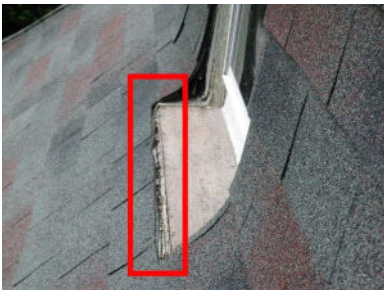
The trim in various areas show signs of deterioration and will require replacement. It is recommended after replacement that all area be covered with aluminum to reduce future maintenance.

ESTIMATED COST \$250.00-350.00 each Replace the rotted wood trim in the various areas

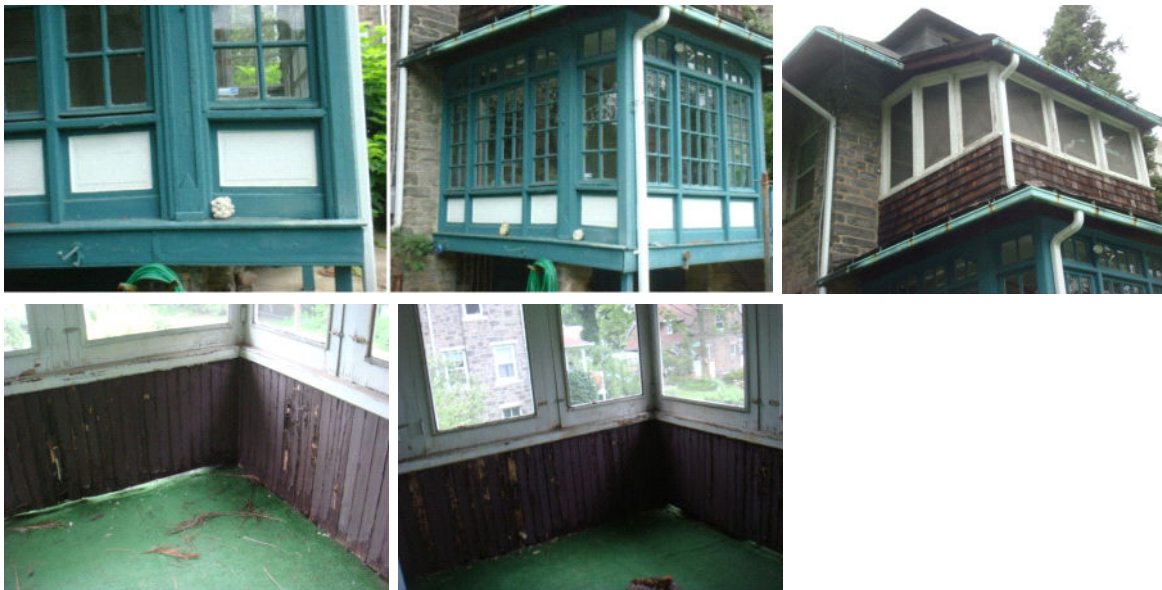
The wood insills for the accessible windows, in some areas, were in poor condition. Failure to properly maintain these areas will lead to failure and water infiltration. It is recommended that all sills be properly painted and repaired on an as needed basis. Some areas may require additional repairs prior to painting, the cost of repairs or replacement will be additional.

ESTIMATED COST \$150.00-250.00 each Repair or replace damaged wood window sills. Hidden damage if found will incur an added cost for repairs. The removal of the lead base paint will entail an added cost.

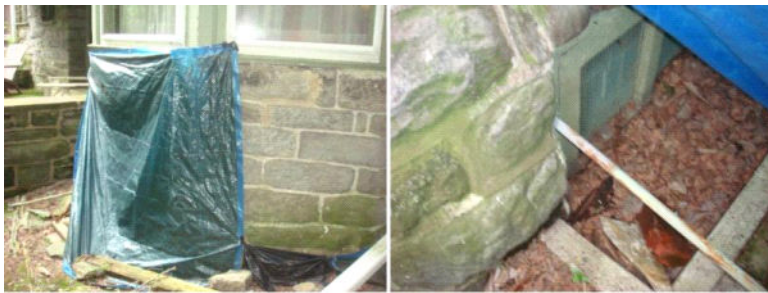
There are signs of deferred maintenance. It is recommended that a full survey of all exterior painted surfaces be performed by a qualified contractor with an estimated for painting and repairs if necessary being provided. There is considerable areas of deferred maintenance visible. In addition it can be expected that when a full survey is taken additional damage will be found. It is recommended that a budget of \$4500.00-5000.00 be established for repairs and/or replacement of the wood, in addition to the cost of lead removal and if necessary any custom wood. Considering the age of the property it maybe assumed that lead base paint was used at sometime in the past. Care should be used when working on any surface that has or may have had lead base paint installed. For additional information you can access <http://www.leadsafeusa.com/>.

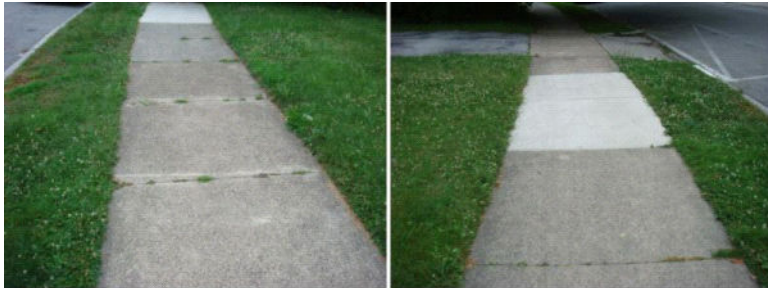
It has become apparent that some insurance carriers are requiring all uneven or cracked sidewalks, walkways and steps to be replaced as a requirement for insurance. If your carrier imposes these requirements an extra cost will be incurred above that indicated for "ramping". This may be several hundred dollars depending on the amount of work required.

ESTIMATED COST \$3.50.00-5.50 per square foot Replace the damaged and/or deteriorated concrete walkway to or around the house.

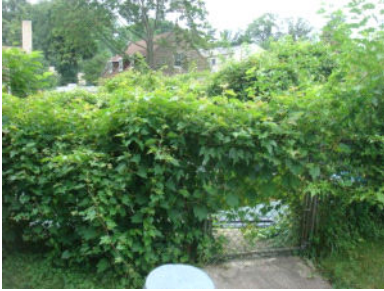
The trees and/or bushes adjacent to the building are hitting and rubbing against the building. This will in time cause wear and damage the building in any place where there is contact. We recommended that they be trimmed so as not to have direct contact with the building. This will also allow for an inspection of any hidden areas for possible damage. In areas where access was impeded no visual inspection was performed at this time. All climbing vines should be removed because they damage the areas where they attach themselves to the building. In time this will cause deterioration of the masonry joints and walls. Removal will also allow for an inspection of any hidden areas. In areas where access was impeded no visual inspection was performed at this time. Keep trees trimmed so that branches are at least 7 feet away from any exterior house surface. This will help prolong the life of your siding and roof and prevent insects from entering your home from the tree. Vines should be kept off all exterior walls, because they can help open cracks in the siding, which allows moisture or insects to enter the building.

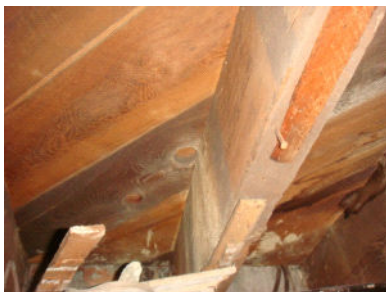
There are visible failed or compromised joist present that were *improperly repaired* in the past. The joist are located in the basement. Proper repairs are necessary at this time.

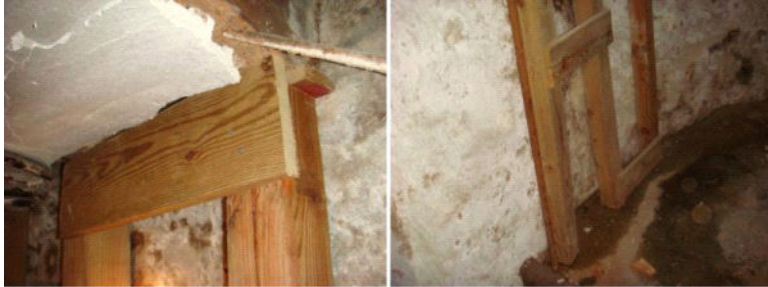
There was what appears to be past termite activity in the basement. This should not be considered a termite inspection which must be performed by a certified individual, nor is this to be considered a list of all infested areas. A complete inspection by a state certified individual is required. Termite infestation and damage can be very extensive, is often hidden, and cannot be always found by a visual inspection. As per the American Society of Home Inspectors standards of practice, our inspection is of visual and accessible areas only. If you are concerned about hidden damage in this or other areas of the building, a through inspection is necessary that may require removal of wall, floor and ceiling covering. This should be arranged and performed by a qualified individual. All persons performing WDI inspections in this state, are required to be licensed.

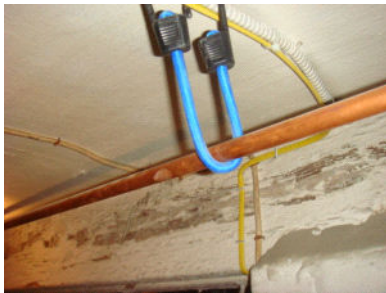
While lead feeds were not visible considering the age of the building they are possible. These are very old and subject to failure at anytime. It is recommended that you budget for replacement on an as needed basis. In addition, whenever renovations are being performed all lead and galvanized pipe should be replaced when observed. The cost of replacement will depend on the areas involved, access and the amount of piping required.

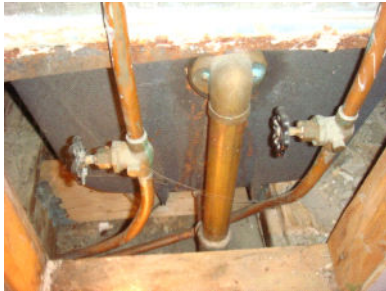
The faucets and diverters are in fair condition for their age and replacement should be budgeted for in the near future.

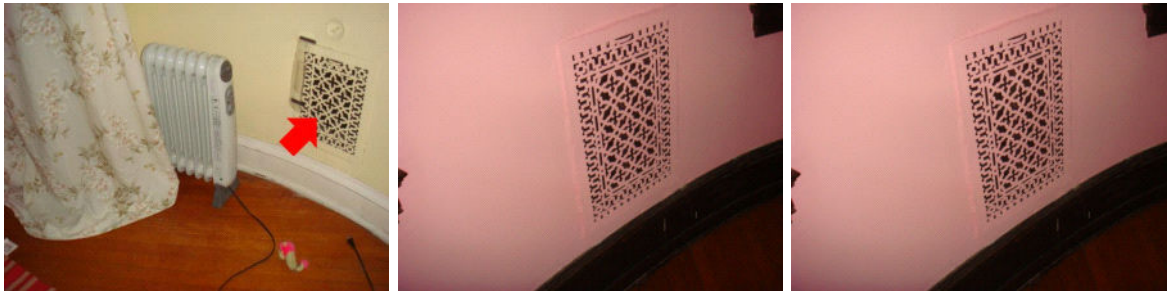
Dampers have been installed in various locations and are a good means of adjusting air flow to the various areas, both winter and summer. This is common and necessary for forced air systems. It is recommended that the settings for both seasons be marked on the ducts for future reference.

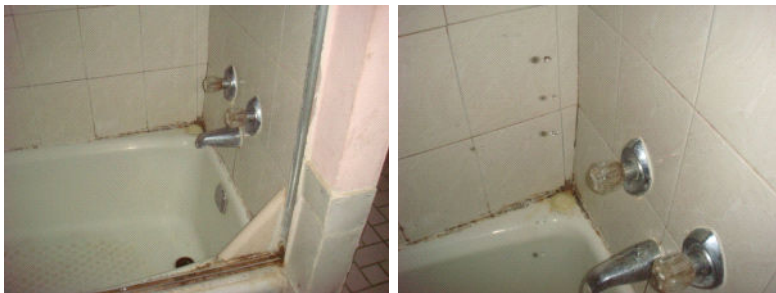
It is important to maintain a good seal around the tubs, showers and floor joints in all area where water may infiltrate. All joints should be sealed with a quality latex or silicone caulk. Failure to maintain the caulking will result in leakage to the floor below and or deterioration of the sub straight for the wall covering. This can lead to extensive damage to the substrate requiring replacement. In addition any water leakage may lead to mold. Replacement of the caulking is necessary for the hall bathroom tub area.

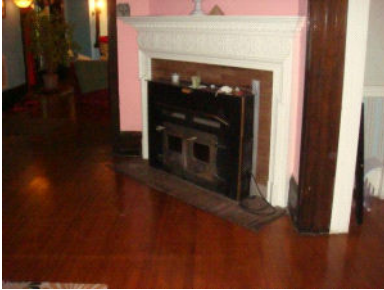
The fireplace in the second floor office appears to have been modified and should not be used until inspected and certified safe.

ESTIMATED COST Have the listed fireplace cleaned, repaired and certified safe by a licensed chimney sweep, if any of the other fireplaces are to be used these too must be certified also. Until that time under no circumstances should the fireplace be used. If not repaired the unit should be permanently sealed and considered unsafe. The cost of repairs will be additional and depend on the extend of the defects found after cleaning and inspection. All inspections and repairs should be performed by an individual certified in fire place repairs having one or more of these certifications CSIA, NFI and F.I.R.E.

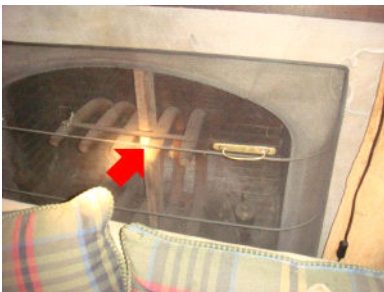
The living room fireplace has been modified and it appears the flue for the heater runs through it. Therefore it can not be used. If you are concerned about this unusual installation further evaluation is recommended.

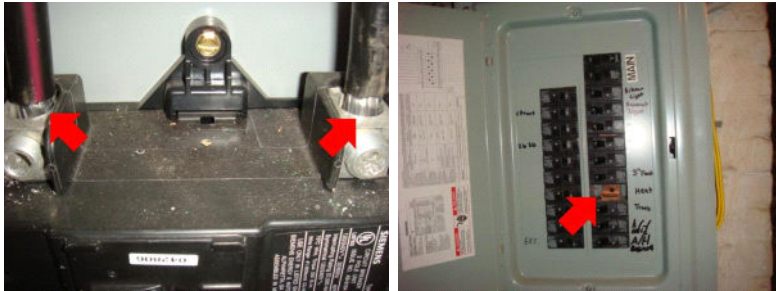
The sub panel, in the basement is improperly installed as per today standards. All sub panels must consist of four (4) wires and have the neutral and ground isolated. In a normal panel the neutral and ground are both connected to the same point of termination. Although there are four wires the neutral and grounds are not isolated.
