# **STUCCO REPORT**

**1234 Any Street  
Philadelphia PA 19100  
PREPARED BY  
INSPECTIONS UNLIMITED INC.**

Re: 1234 Any Street  
Philadelphia PA 19100

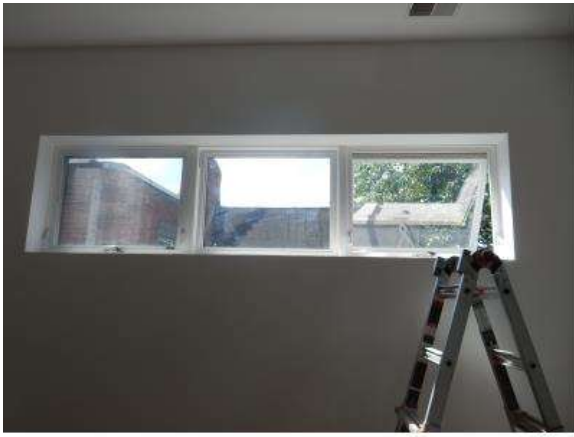
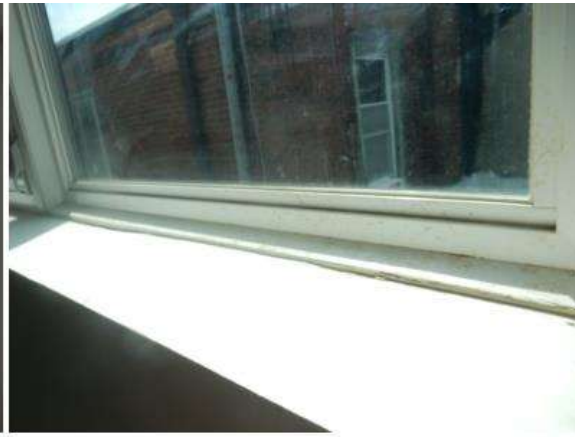
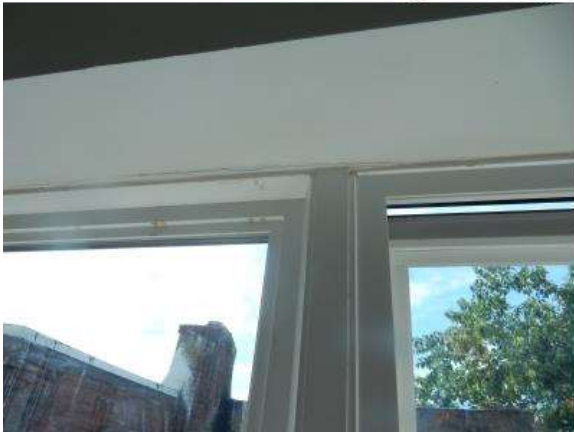
Although not a part of an invasive stucco inspection it was observed that there is staining and signs in various areas from what is assumed moisture infiltration. Whether this was the result of roof issues and or the installation of the windows is beyond the scope of our inspection. The pictures below are a sampling of this condition, but not all areas.

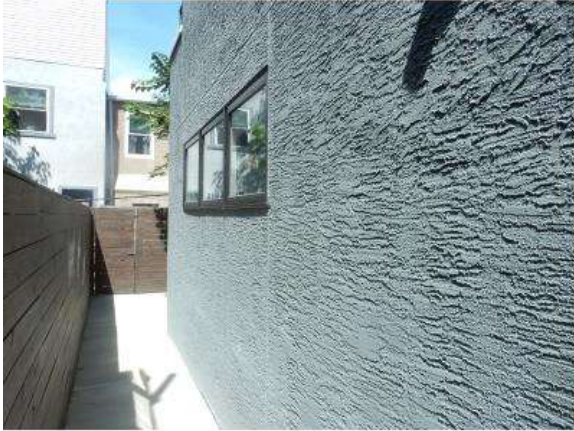
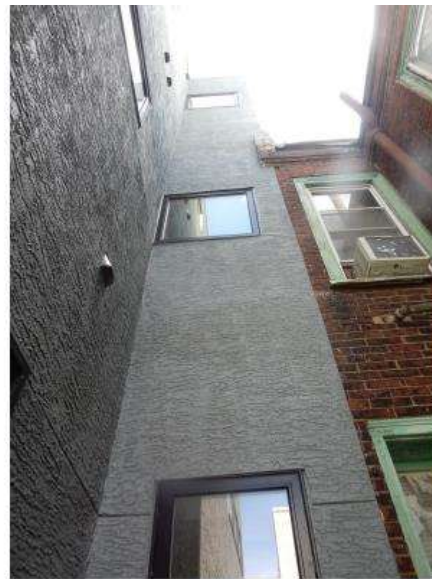
Multiple windows were installed "flush" with the surface of the stucco. Because of the lack of a reveal and the lack of stop bead, the caulking is the main deterrent to water infiltration. Proper caulking under these conditions must be done more often and is difficult. This must be monitored and replaced in the future on an as needed basis to reduce the chance of water infiltration.

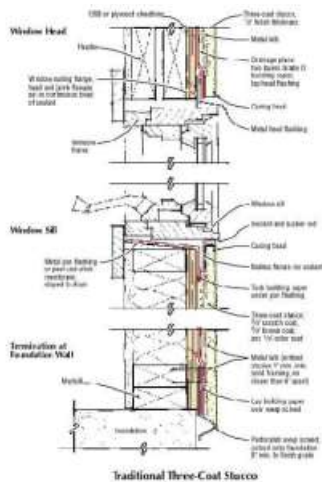
The visible details and flashing do not meet the current requirements. These requirements state that a properly detailed and caulk joint be present everywhere the stucco meets a dissimilar surface such as windows, door frames, soffits and penetrations. Failure to provide these conditions will lead to water infiltration and the resulting damage. ***These can not be retro fitted.***

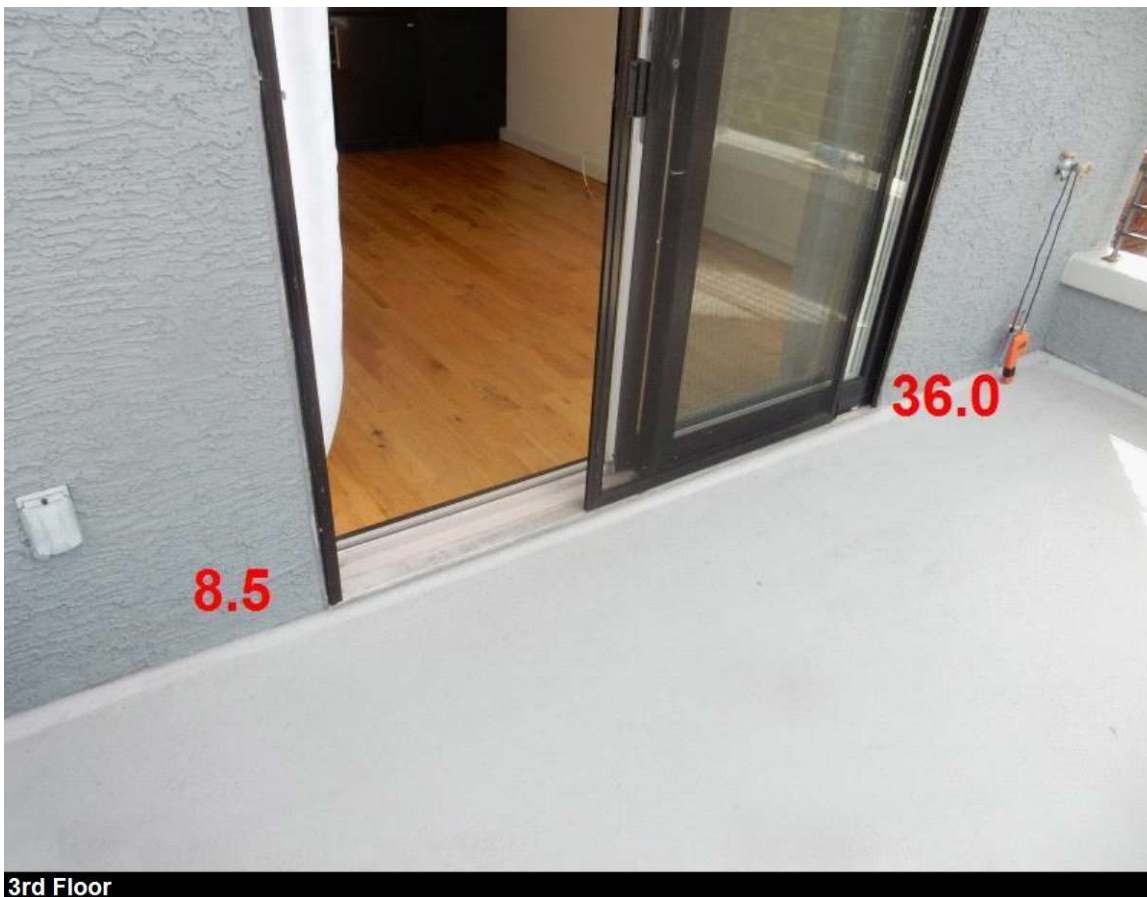
**3rd Floor**

***The 36.0 % moisture readings at the 3rd floor doors are an indication of area of concern. It is our opinion that the stucco be removed exposing the framing. This will allow for a determination of damage to the substrate, framing etc. Any and all damaged items must be replaced. When the stucco is replaced it should be done to the current standards with stop bead, weep screeds etc. For a proper repair it is recommended that the all the stucco on this "plane" of the doors be removed and replaced.***
