# **INSPECTION REPORT**

**6789 Locust St  
Philadelphia PA 19100  
PREPARED BY  
INSPECTIONS UNLIMITED INC.**

August 24, 2010

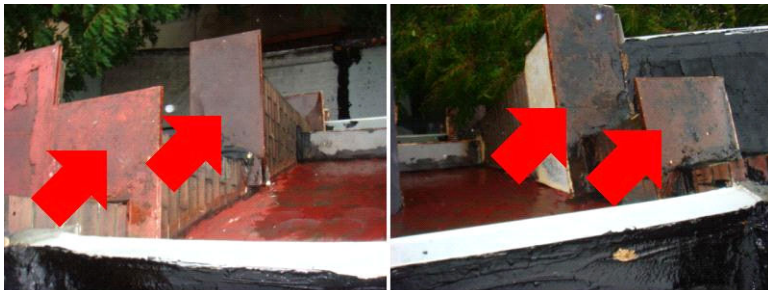
**PAINT ALL EXPOSED METAL**

It is recommended that any areas not covered be capped with aluminum to reduce maintenance. Areas in need of repairs must be properly repaired and painted before they are capped. The cost of capping may range from \$40.00-60.00 per window. Prior to capping repairs, at an additional cost should be made on an as needed basis.

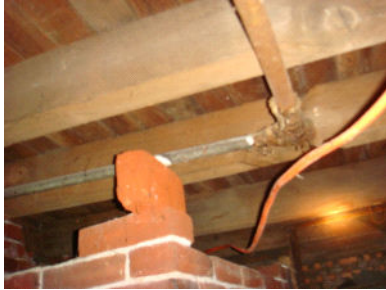
The limited visible distribution piping is copper and shows no signs of excessive deterioration inconsistent with the age of the building.

The visible piping is copper and shows of sagging in the basement, it is important that all pipes be properly supported using copper or plastic strap. Otherwise the system shows no signs of excessive deterioration inconsistent with the age of the building.

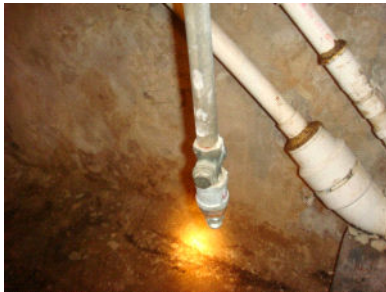
There is no cap or plug for the disconnected or terminated gas line in the, basement. Repairs are necessary to prevent possible future leaks and related damage.

**ESTIMATED COST \$25.00-35.00 each Install a permanent cap for the disconnected or terminated gas lines in the laundry room.**

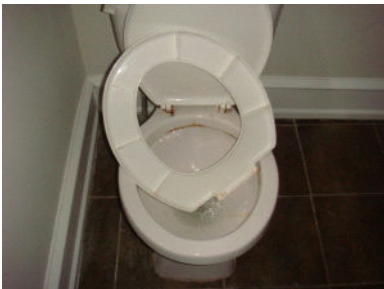
The toilet is loose and can be moved at the base in the, hall bathroom of the second floor, All toilets must be properly secured to the floor. This must be repaired because the seal of the "wax ring" between the toilet and the floor flange stops the sewer gases from entering the room and water leakage with resulting damage to substrate and surrounding areas. This can be corrected by installing a new "wax ring" and securely bolting the toilet down. Care must be taken to avoid over tightening the bolts and cracking the base. *There is always the possibility of hidden damage to the surrounding areas and where possible the areas below the toilet.*

**ESTIMATED COST \$125.00-175.00 each Re secure the toilet in the listed areas and replace the wax ring as necessary. This and all plumbing work should be done by a licensed plumber. If it appears that the substrate or area surrounding the toilet is damaged further investigation and repairs maybe necessary. The cost will be determined after the extent of damage is determined. It is assumed no additional work will be required.**

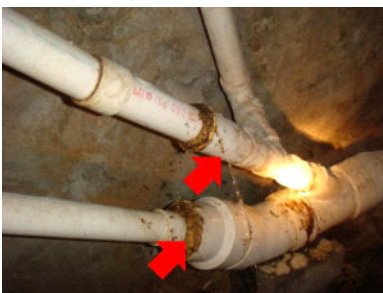
Repair or replace as necessary the improperly installed PVC drains in the basement.

**ESTIMATED COST \$300.00-400.00 Repair or replace the improperly installed and leaking PVC drain lines in the basement.**

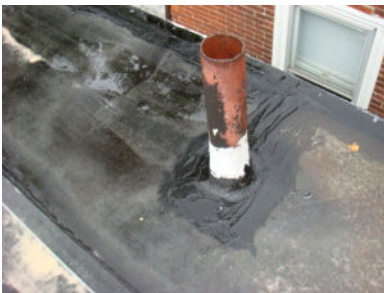
The vent stacks to the outside are cast iron in the accessible and visible areas.

**ESTIMATED COST \$30.00-50.00 Properly support the drain pipe in the basement at 5' intervals.**

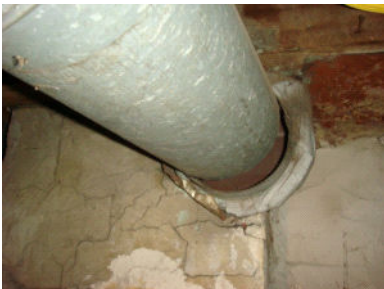
There is notable air lose in the area of the ducts. Although not a major concern the efficiency of the heating and if present cooling system will be diminished. It is recommended that all leaks be sealed with a proper material.

**ESTIMATED COST \$75.00-125.00 Properly seal all openings in the ducts to reduce air lose and increase the efficiency of the system.**

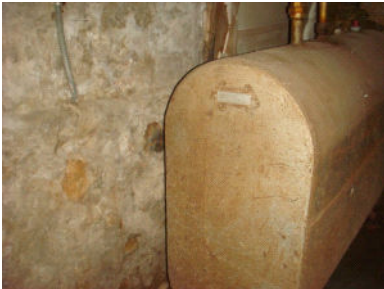
There was no clean out present, this is common with some gas fired furnaces. As inspectors we use the cleanout, when present to check for deterioration or blockage in the chimney.

There is an abandoned oil tank in the basement, we recommended removal of the tank and all lines. In addition, that all openings to the outside be sealed.

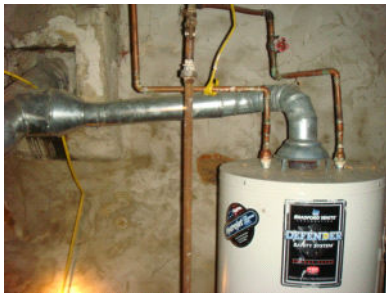
The water heater is vented to the chimney through a metal stack. As installed the stack is not properly pitched to the chimney. All vents should be mechanically secured at all joints and installed with an upward pitch of 1/4" per foot to the chimney. Failure to properly pitch the vent can lead to failure due to condensation, back drafting or other serious defects.

**ESTIMATED COST \$75.00-125.00 Properly pitch and support the vent from the water heater to the chimney. All vents should be mechanically secured at all joints and installed with an upward pitch of 1/4" per foot to the chimney. All vent piping must be of an approved material for the type fuel being used. Considering the physical conditions this is not possible and replacement of the existing heater with a "short" heater will be necessary at a cost of \$550.00-750.00. All work must be performed by a licensed contractor in this trade.**

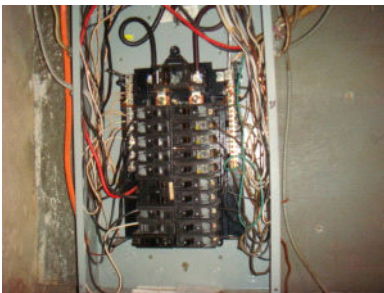
**The visible wiring was traced from the panel box in all visible and accessible areas. The visible wiring was Romex (non metallic sheathing) and/or Bx (metallic sheathing) MC- Metal-Clad cable, this wiring in generally serviceable condition. The visible and accessible solid branch wiring was copper for 14 ga, 20 ga and 10 ga circuits. In some cases stranded aluminum is and can be used for larger circuits.**

**In some locations active (live) knob and tube wiring is present. Knob and tube wiring is extremely old and most likely the original wiring installed at the time of the original construction or the adding of electricity buildings built before the advent of electricity. This type of wiring was common until the about 1940. The wiring tends to become very brittle because of its age and in some cases due to improper use over the years. When and where possible, all knob and tube wiring should be replaced with Romex (non metallic cable) or MC- Metal-Clad cable and never should it be added to or modified in any manner, except to be replaced. In some instances cases adding to knob and tube wiring have been noted, but these require special conditions and techniques, the same as when originally installed. Today it is very unlikely that an individual would have these skills and or would properly perform such additions, as replacement is the**
