# **INSPECTION REPORT**

**6789 Locust St  
Philadelphia PA 19100  
PREPARED BY  
INSPECTIONS UNLIMITED INC.**

Re: 6789 Locust St  
Philadelphia PA 19100

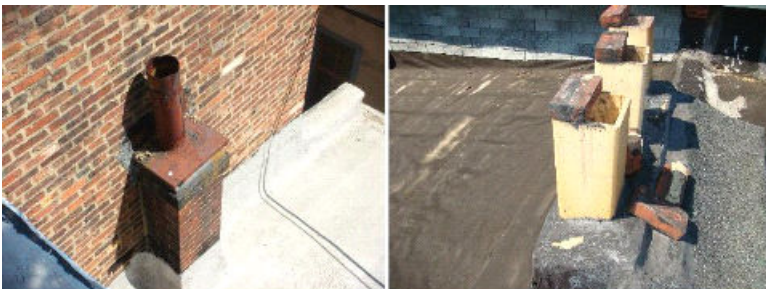
There are multiple abandoned chimneys present on the roof These should be sealed and stabilized. Failure to make these repairs will lead to water infiltration and result in possible additional damage.

**ESTIMATED COST \$150.00-200.00 each Seal and stabilize the abandoned chimneys. If hidden damage is found an added cost will be incurred. Before the chimneys are sealed it must be made sure that they are not being used.**

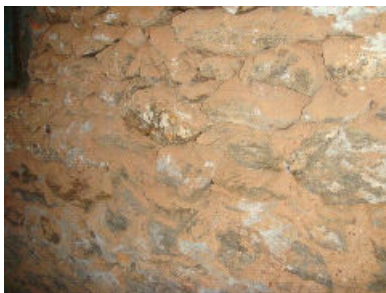
The stone walls were accessible and visible inspected for the majority of the area. The accessible areas of the walls were in fair condition considering the age of the building. Some areas of the walls have deteriorated mortar and cement coating, "dash coating". This is a normal condition caused by water infiltration and age with all stone foundation buildings. The walls should be "dash" coated with cement over galvanized wire lath where necessary. It is possible that non accessible areas also may require repairs and if in the future these areas are made accessible repairs should be made.

**ESTIMATED COST \$ Dash coat the walls of the basement as necessary. All coatings should be installed over galvanized wire lath. A budgeted cost of \$9.00-11.00 per square foot should be used for work at today's prices.**

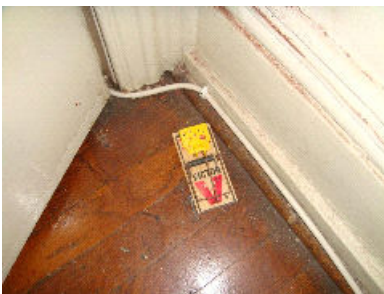
A mouse trap was seen in one of the units and the tenant confirmed that there are indeed mice in the building. This building must be properly exterminated by a qualified exterminating company.

**ESTIMATED COST \$250.00-400.00 Have this building exterminated by a qualified licensed contractor as necessary.**

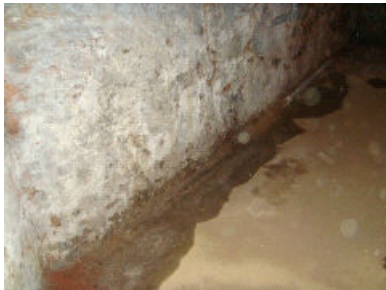
As discussed proper grading is the first choice to reduce water infiltration, but if that does not adequately correct the problem a perimeter drainage system will be required. There are visible signs of water infiltration at this time in the basement. The proper installation and discharge of a sump pump, the proper discharge of all downspouts and grading all areas away from the building a minimum of 3' and angled at a minimum of 1" per foot can in most cases reduce or eliminate problems with water infiltration. To determine the best method of dealing with this problem is beyond the scope of a building inspection. A consultation with a qualified contractor is recommended to make this determination and decide the best means of correcting the problem.

**ESTIMATED COST \$125.00-175.00 Consult with a qualified contractor to determine the best means to correct the water infiltration to the basement and or crawlspace**

**areas, the cost of corrections will be additional and can range from \$1500.00-8000.00±. The average cost will range from \$35.00 45.00 per foot in addition to the cost for the sump pump etc, which can add and additional \$700.00-900.00 to the cost. In instances where access or existing conditions are difficult an additional cost maybe incurred.**

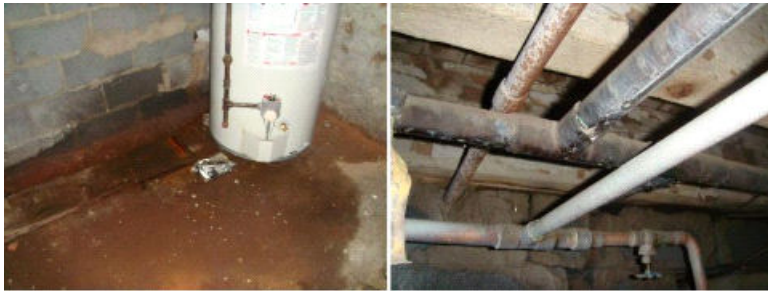
In the rear of the basement near the water heater there is a leaking water pipe that is in need of repairs at this time.

**ESTIMATED COST \$ 75.00-150.00 Repair the leaking water pipe in the rear of the basement near the water heater as necessary.**

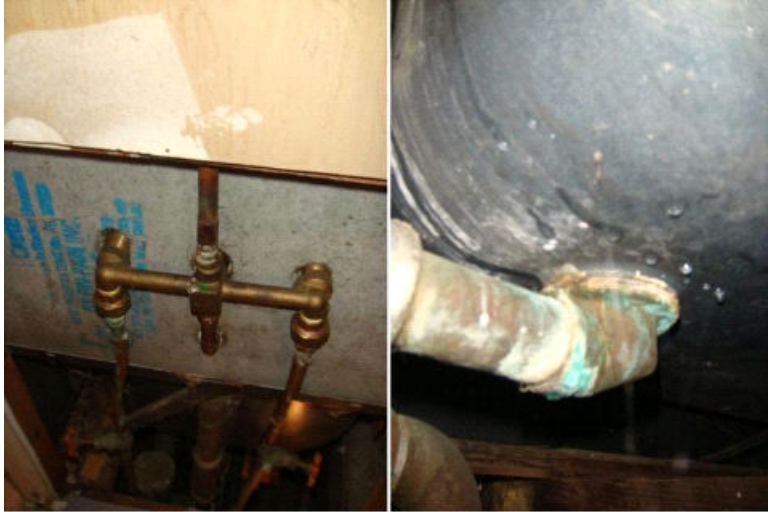
The plumbing access panels are located in the bathroom and visible in the basement. Active leaks were visible from the basement. Repairs and/or replacement will be necessary.

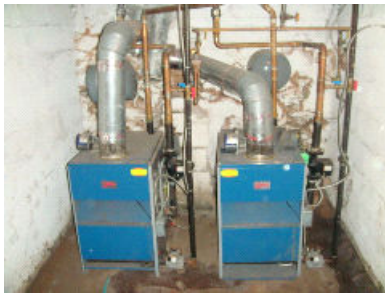
The hot water boiler(s) are fueled by natural gas, there are two heating units located in the basement.

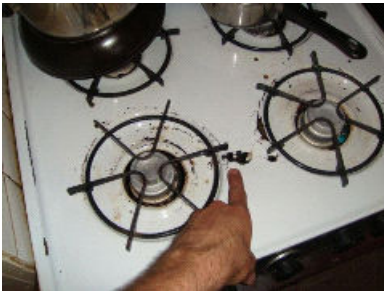
most areas. Replacement is recommended and maybe required by the local gas supplier. Because we do not move or disassemble appliances we do not check for this type of installation. No calibration nor checking as to the accuracy of the temperature controls was performed as a part of this inspection and is beyond the scope of a home inspection. There is a stove in unit 6 where the top has rusted or deteriorated and is in need of replacement at this time.

**ESTIMATED COST \$250.00-450.00 Install a gas range for the kitchen in unit 6 as necessary.**

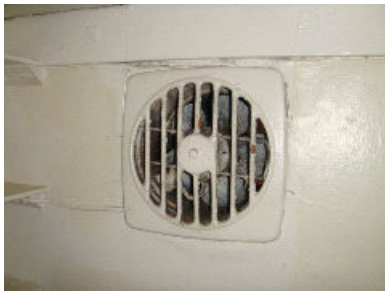
The kitchen exhaust in unit 1 requires repair or replacement for proper operation. At this time the exhaust fan is not working.

**ESTIMATED COST \$150.00-400.00 Repair or replace the kitchen exhaust in unit 1. It is assumed that no opening of walls or ceilings will be required. It is also assumed that a "standard" type hood will be used..**

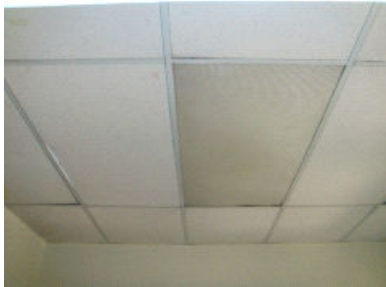
The suspended ceilings in some locations were installed in such a manner that removal of the panels was not possible due to the chances of doing damage. The conditions of the ceilings and walls of the spaces above is not known nor inspected, because of this no opinion can be made. If you are concerned, you should consult the current owner as to the conditions present above the ceilings and or the reason for the installation of the suspended ceilings. ***IF AT A FUTURE DATE YOU DESIRE TO REMOVE THE SUSPENDED AND OR 12 X 12 CEILINGS EXTENSIVE REPAIRS OR POSSIBLE COMPLETE REPLACEMENT OF THE ORIGINAL CEILING MAY BE NECESSARY.***

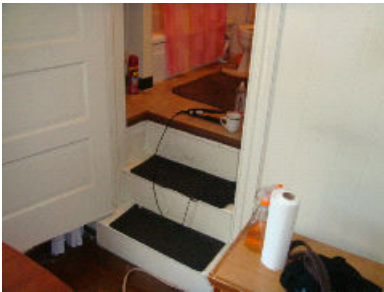
There is no rail installed to the bathroom in unit 6. This creates a safety hazard and should be properly installed. The rail must be installed from the top of the steps to the bottom and must project 3½", be between 34"-38" from the riser of the steps and be 1 ¼"- 2" wide.

**ESTIMATED COST \$100.00-125.00 Install rails to the bathroom in unit 6, attached to the wall.**

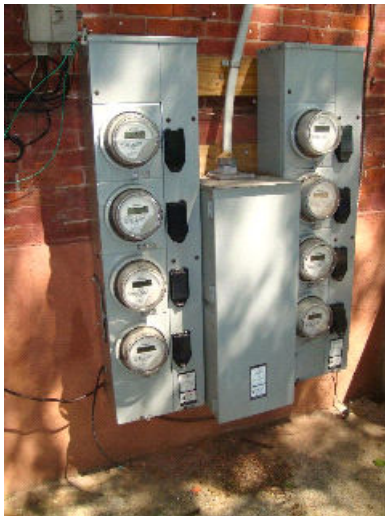
The electrical services terminate outside at the meters with circuit breaker sub panels in the units and the basement. Because the main breaker is present at the meter, that is considered that main panel, and all other panels are subs and should be wired as such. If possible a lock should be installed on the main disconnect covers to prevent unauthorized access to the main breaker.

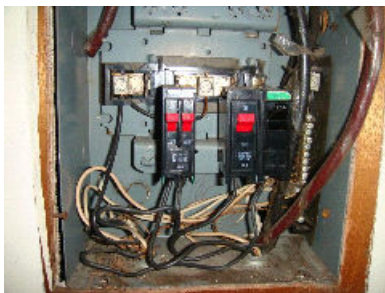
The covers for the panels in unit 7 and 4 were removed and the interior was visibly inspected for signs of arcing or over heated circuits, no visible signs of damage were observed. It was noted however that the service to this unit was only a 12 gauge two wire system wired as a 120 volt service. This is inadequate by today's standards and replacement is strongly recommended at this time. It is very likely that this condition exists in other circuit breaker panels throughout the building. These too should be repaired as needed and as recommended in the section where 4 wire serviced and isolating are discussed.

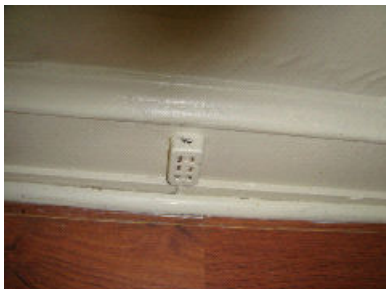
There is lamp cord installed in a permanent manner in various areas. This is improper and potentially dangerous. All lamp cord used for electrical outlets etc. should be removed. If additional receptacles or switches are necessary they should be installed by a licensed electrician using approved methods and either Romex or MC cable. The cost of this will vary depending on the methods of installation and the accessibility in the area.

**ESTIMATED COST \$50.00-75.00 each Remove the temporary receptacle from all areas where it has been permanently installed. If replacement of the receptacle is necessary or desired, there will be an additional cost.**

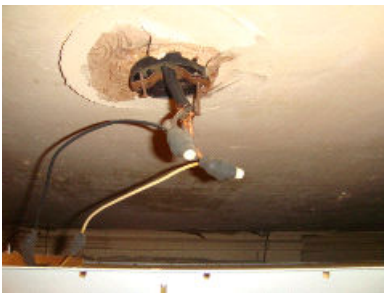
Correct the open splice above the suspended ceilings in unit 2.

**ESTIMATED COST \$75.00-125.00 each Correct the open splices in all areas above the suspended ceilings in unit 2. All live wires must be in an approved junction box with a cover when spliced or terminated. Failure to properly enclose a splice or wire termination can lead to fire and/or electrical shock, serious injury or electrocution.**

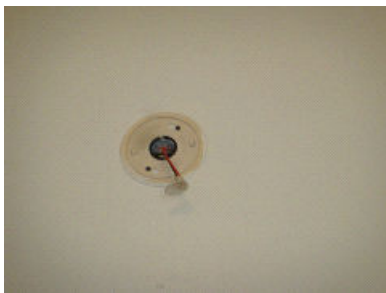
Correct the loose and or missing smoke alarms throughout the building, bringing it up the current safety standards.

**ESTIMATED COST \$50.00-75.00 each Repair the loose smoke alarms throughout.**
