INSPECTION REPORT

**2100 Williams Ave
Philadelphia PA 19100**

**PREPARED BY
INSPECTIONS UNLIMITED INC.**

February 27, 2007

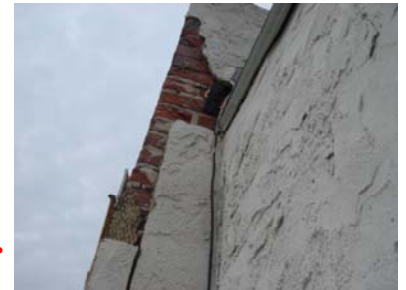
The chimney is in need of rebuilding at this time from above the roof line. It is important that this work be professionally done to insure the future stability of the chimney.

ESTIMATED COST \$1400.00-1800.00 Rebuild the chimney on an as needed basis to the point of the existing termination. This cost includes scaffolding. It is important that this work be professionally done to insure the future stability of the chimney.

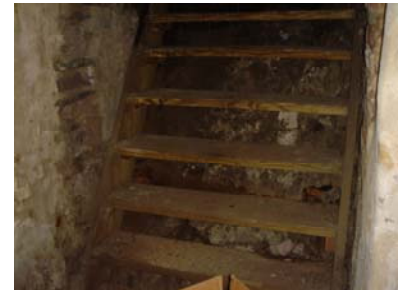
The installed "Bilco" or "Bilco" doors to the basement are metal and appear to be in fair condition for their age. Although they are not 100% water tight when properly installed they should greatly reduce the water infiltration.

The wood steps to the basement are in fair condition, due to the excessive amount of items in the basement access was not practical.

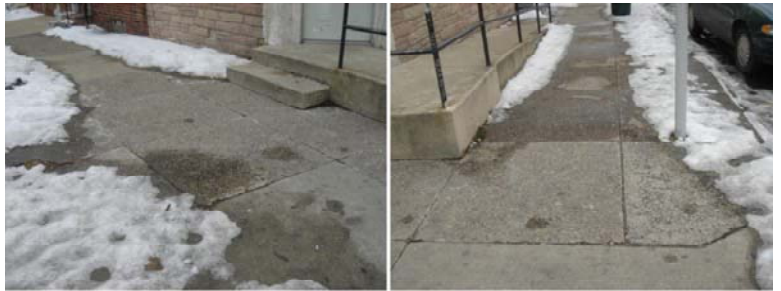
The concrete sidewalks and/or walkways are in fair condition for there age, with some areas covered with snot. It is important that all walkways and steps be kept free from tripping hazards both now and in the future. This applies to broken or lifted concrete and any

other area that may cause a person to trip. In cases where the steps are of a solid material, such as concrete or brick and are adjacent to the home the joint between the steps and the building is subject to movement. This joint should be monitored and when necessary repaired and or filled with a flexible sealer such as a silicone caulk. This will help reduce water infiltration to the building and deterioration of the steps.

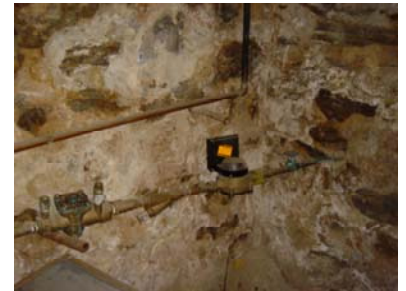
The building has a 3/4" copper public water service and terminates in the basement. In the event of a leak, turn the water off at this location or the individual appliance until repaired. All valves should be accessible at all times in the event of an emergency.

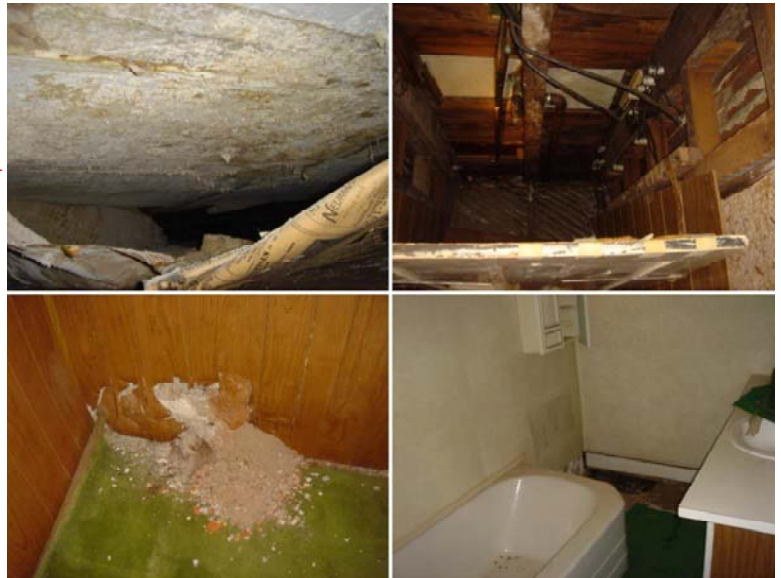
As discussed this property requires complete renovations for the second and third floors, including all walls/ceilings, plumbing, electrical, HVAC etc. When this work is done and walls opened additional problems, some structural maybe found and should be expected.

As discussed these areas have not been occupied for many years and finding newspaper on the floor of the third floor from 1943 should confirm this in part. Because of the lack of gas, water and electric the various system if present were not fully inspected. Although renovation without a complete rehabilitation are possible it is not a cost effective means of proceeding and therefore not recommended.

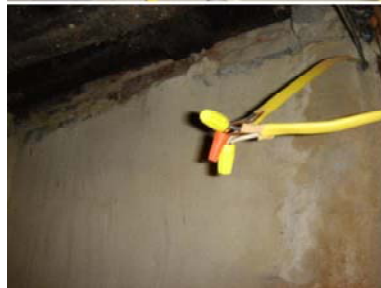
All live wires must be in an approved junction box with a cover when spliced or terminated. Failure to properly enclose a splice or wire termination can lead to fire and/or electrical shock, serious injury or electrocution.

The visible and accessible receptacles were two prongs without a ground in some visible and accessible areas. In those areas accessible a sampling of receptacles and switches were tested and operated. In areas where three prong grounded receptacles are required or desired this can be accomplished either by rewiring from the main panel with new three conductor wire or a GFCI receptacle or circuit breaker can be installed. The installation of three prong receptacles without a proper ground gives a false sense of security and should be corrected. Some older two prong receptacles do not have polarized plugs, one side is wider than the other, as now required for some modern appliances. Although an inconvenience this does not constitute a defect. Consult with a qualified licensed electrician for the above mentioned work to rectify the condition.
