INSPECTION REPORT

**6789 Newtown Road
Holland PA 18900
PREPARED BY
INSPECTIONS UNLIMITED INC.**

September 3, 2010

On September 2, 2010, I inspected the above referenced property, as per your request. The home is a 2± year old building. The temperature was approximately 86± degrees and the weather was clear. The following is a summary of the conditions found from a visual inspection at that time.

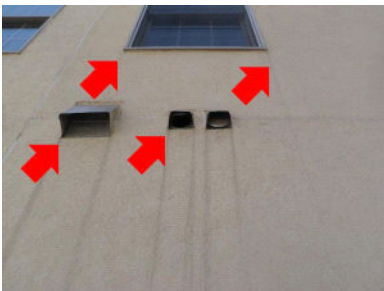
It was observed in the rear of the building around the exhaust vents and windows that there is staining present beneath. Staining is typically an indication of moisture collecting behind the stucco. It was also noted above the corner of the garage that the stucco has been patched because of a crack in the stucco. This typically happens because of the lack of a stop bead and or expansion joint. These items were missing in various areas and while cracks were present at this time in all locations, they can start at any time. The lack of proper detailing at these areas will lead to water infiltration and the resulting problems consisting of mold, structural damage to the framing, degrading of the insulation etc.

TO BE CORRECTED BY THE BUILDER Have additional inspection consisting of thermal imaging/ thermography performed to determine the presents and or extent of damage caused by improper or missing flashings/detailing. Invasive inspections will be additional and are destructive in nature and will require permission.

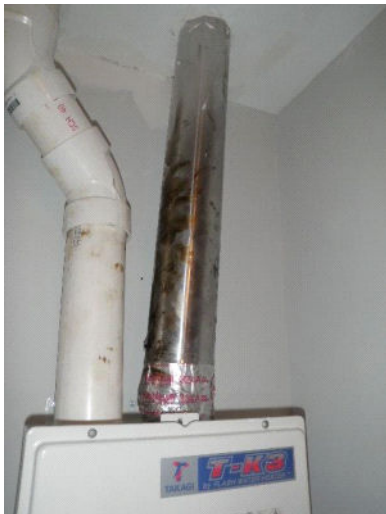
Inside at the unit the chimney has "aluminum" foil tape at one joint. There are some tapes that are designed for high heat, but it is not know if this is such a product.

TO BE CORRECTED BY THE BUILDER Confirm the reason for the aluminum foil tape on the tankless water heater vent and that the tape used is rated for the purpose.

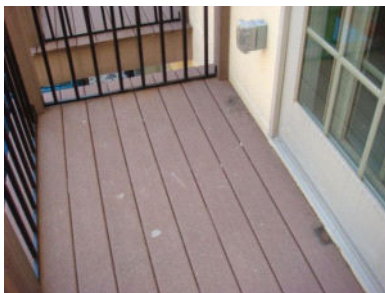
From our visual inspection it does not appear the proper flashings are installed between the deck and the building as now required. Proper flashing is one of the most important precautions in deck and or steps construction. Keeping water out from behind your deck frame and siding is very important. If water were to penetrate, it would not only cause rot damage but it may rust the attachment hardware and cause structural failure. There have been many stories over the past years of decks falling off a house under a party of people. Water penetration is one major reason for some of these events.

TO BE CORRECTED BY BUILDER Install 1/2" through bolts, a minimum of two (2) per joint staggered, for all the structural members of the deck or install manufactured connectors designed for the purpose. This includes but is not limited to the posts, beams, steps and headers. For points of attachment to the building when not possible properly sized lag bolts are often used. These must be pre drilled and of a length adequate to penetrate the header and through to the interior structure. Failure to properly attach the various members may lead to failure of the structure.

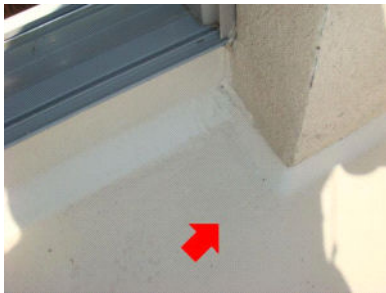
The fourth floor balcony has a synthetic decking material that is assumed to be designed for the use. The deck should typically be pitched to the outside to allow for water drainage. This deck appears to be level or possibly tilting towards the building. This may in the future present an issue, also be aware that the water will not drain and in cold weather ice may form.

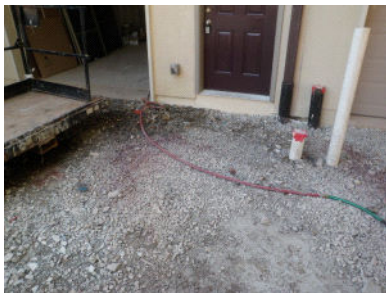
The driveway requires installation along with any related items etc.

TO BE CORRECTED BY THE BUILDER Install a finished driveway and all related components of the system.

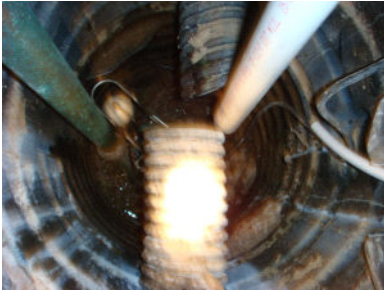
The sump pump discharges into the sanitary system. This is not permitted in most areas because this method of discharge poses an additional cost and burden on the sanitary system, all discharges should be to the outside placed a minimum of 3' and down grade from the building.

TO BE CORRECTED BY BUILDER Remove the sump pump discharge from the sanitary drain system and properly seal all openings. The proper discharge of the sump pump should be placed at a minimum of 3' and down grade from the building.

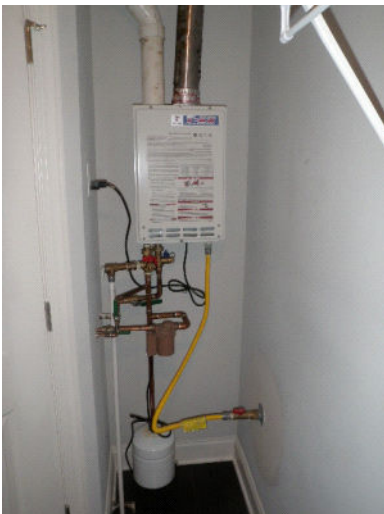
The intake and discharge pipes for the tankless water heater were poorly installed. The PVC intake vent pipe is cracked and broken inside and the stainless steel vent pipe was covered in what appears to be roofing cement. This does not appear to be a professional installation and must be corrected by a licensed and qualified contractor.

TO BE CORRECTED BY BUILDER : Replace the cracked PVC intake pipe for the tankless water heater and removed the roofing cement from the exhaust pipe as necessary.

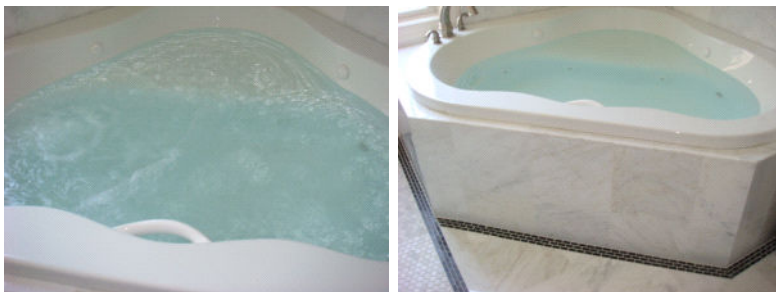
Some trim pieces were missing and must be installed.

TO BE CORRECTED BY BUILDER Install all missing trim pieces etc for the whirlpool.

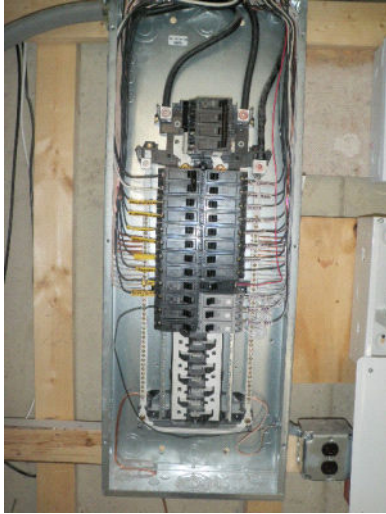
There are improperly sized breakers installed, this is a potentially dangerous condition. All circuits should be properly protected to avoid the possibility of over heating the wiring, insulation and/or the panel. In changing the devices to the proper size, in relation to the connected wire in some cases the circuits may fail. This is an indication that the wire is not suited for the connected load. In this case, the possibility of new or additional circuits is likely. This condition cannot be determined by a building inspection.

TO BE CORRECTED BY BUILDER Install proper size circuit breakers for all improperly sized devices. In changing the devices to the proper size, in relation to the connected wire in some cases the circuits may fail. This is an indication that the wire is not suited for the connected load. In this case, the possibility of new or additional circuits is likely at an additional cost. This condition cannot be determined by a building inspection.

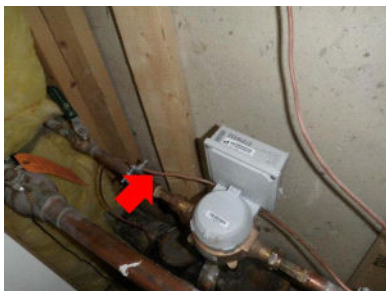
The water meter has a properly installed jumper wire and ground rod installed. Due to the fact that the ground rod is in the ground it is not possible as a part of a home inspection to determine if the full 8' of rod has been driven into the ground, this must be assumed. The termination of the ground wire was visible determined and inspected. All grounding wires should be checked periodically for proper connections.

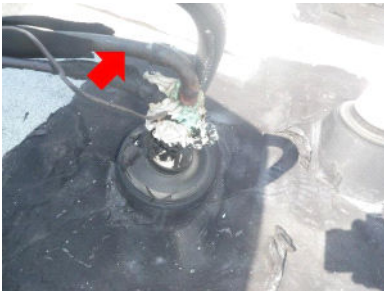
It was observed that the insulation on the large suction line at the coil is missing. This must be replaced so that the air conditioning system will function properly and not freeze up.

TO BE CORRECTED BY THE BUILDER: Replace the missing insulation on the large suction line at the coil as necessary. This should be repaired by a qualified HVAC contractor.
