INSPECTION REPORT

**1234 Baker Ave
Philadelphia PA 19100
PREPARED BY
INSPECTIONS UNLIMITED INC.**

Re: 1234 Baker Ave
Philadelphia PA 19100

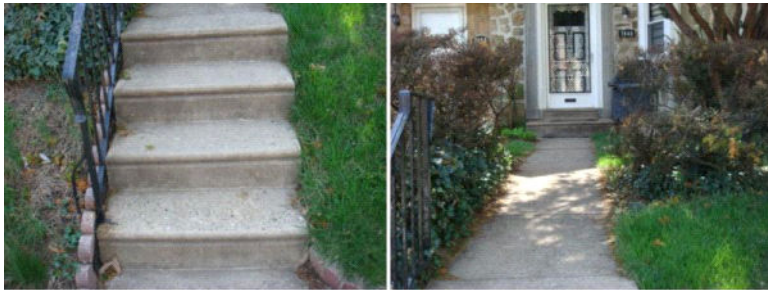
The installed rails are in fair condition at this time. It is important that all rails be monitored and repaired on an as needed basis. In time rails tend to become loose or show signs of deterioration from exposure and/or use. Failure to properly maintain rails can result in serious injury to individuals.

The trees and/or bushes adjacent to the building are hitting and rubbing against the building. This will in time cause wear and damage the building in any place where there is contact. We recommended that they be trimmed so as not to have direct contact with the building. This will also allow for an inspection of any hidden areas for possible damage. In areas where access was impeded no visual inspection was performed at this time. All climbing vines should be removed because they damage the areas where they attach themselves to the building. In time this will cause deterioration of the masonry joints and walls. Removal will also allow for an inspection of any hidden areas. In areas where access was impeded no visual inspection was performed at this time. Keep trees trimmed so that branches are at least 7 feet away from any exterior house surface. This will help prolong the life of your siding and roof and prevent insects from entering your home from the tree. Vines should be kept off all exterior walls, because they can help open cracks in the siding, which allows moisture or insects to enter the building.

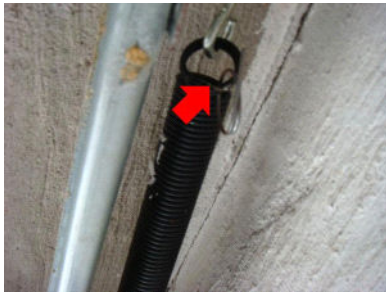
The garage door is operated manually and is satisfactory operating condition for it's age. All garage doors require periodic maintenance such as lubrication of the tracks and hinges.

The garage door bucks, frames are capped with aluminum and cannot be visible inspected. This is sometimes done to cover deterioration of the bucks at the ground level and/or past damage. Deterioration of the bucks is common in this type of construction, due in part to moisture and/or termites. Repairs normally consist of installation of pressure treated wood in place of the existing non-treated wood. No opinion as to the condition of the wood beneath the capping is made nor can be assumed. It is important as with all capped wood that the joints be properly caulked and maintained to prevent water infiltration which will result in deterioration of the wood.

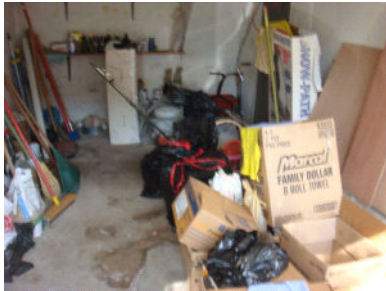
There are minor holes in the ceiling of the garage. All holes must be properly sealed to maintain the fire integrity of the garage. The use of a fire rated material such as cement, stucco, 5/8" fire code dry wall or an approved equivalent material for the ceiling or walls of the garage. If large areas require repairs the use of 5/8" fire code dry wall is recommended . THE USE OF EXPANDABLE FOAM TYPE MATERIALS USED FOR REDUCING DRAFTS ETC. IS NOT ACCEPTABLE. THIS IS NOT A FIRE RATED MATERIAL.

ESTIMATED COST \$125.00-175.00 Repairs are necessary to correct the minor holes in the garage walls and/or ceilings. The use of a fire rated material such as cement, stucco, 5/8" fire code dry wall or an approved equivalent material for the ceiling or walls of the garage. If large areas require repairs the use of 5/8" fire code dry wall is recommended . THE USE OF EXPANDABLE FOAM TYPE MATERIALS USED FOR REDUCING DRAFTS ETC. IS NOT ACCEPTABLE. THIS IS NOT A FIRE RATED MATERIAL.

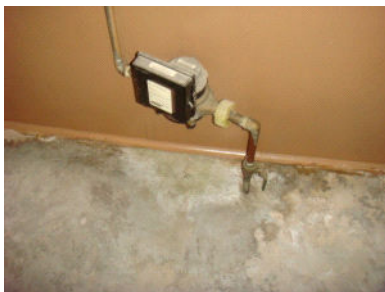
The building has a 1/2" copper public water service and terminates in the basement. In the event of a leak, turn the water off at this location or the individual appliance until repaired. All valves should be accessible at all times in the event of an emergency.

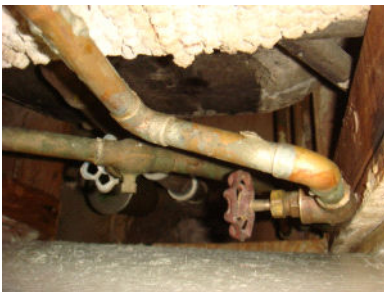
The faucets and diverters are in satisfactory condition for their age. As with all such items repairs and replacement are common and should be expected.

The accessible toilets were checked and there were no signs of loose toilet bowls were noted. If at anytime a toilet should become loose or move when used, this is an indication that repairs are needed and a plumber should be called. Failure to correct this condition will in time lead to water damage to the surrounding floors and or the ceilings below.

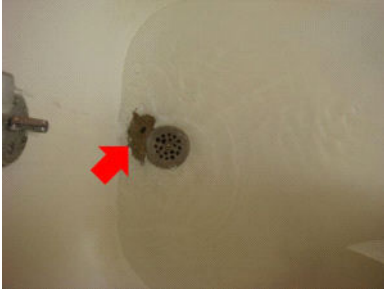
The waste from the building exits to what has been presented as a public disposal system. The conditions of the pipes below the ground, with in walls and/or hidden cannot be determined by a visual inspection and no opinion on their condition is known or is an opinion being presented. The condition of the visible and accessible lines is as noted in this report.

The visible sanitary system drains through horizontal and vertical waste stacks. Drains with in walls, ceilings or otherwise hidden cannot be inspected as a part of a visual inspection. By running the water, we attempt to find active leaks in addition to visually inspecting all accessible areas. However, this is by no means to be considered an inspection of all areas hidden or blocked from view.

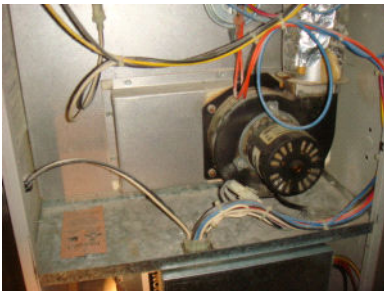
There is one gas fired forced air heater located in the laundry room. Installation in the laundry room is not recommended due the presents of bleach and other chemicals that may have an adverse effect on the heater.

The heater was visibly inspected and is in satisfactory condition for its age and functioning as intended, The heater was visibly inspected and is in fair condition for its age it appears to be 15-17 years old and is nearing the end of its normal life expectancy . In addition to being nearing the end of its normal life expectancy the system is inefficient by today's standards and waste energy. Replacement with a new system regardless of it efficiency rating would be an improvement and should lead to reduced overall energy cost. Obviously the higher the efficiency of the new system the greater the savings and initial cost, but as with all energy saving systems there is a point where it may not be cost effective and a compromise must be made.

ESTIMATED COST \$125.00-150.00 Correct "quick cycling" of the heater, this is necessary to provide proper and even heating. If additional repairs are necessary, an extra cost maybe incurred.

It is recommended that chlorine, bleach etc, not be stored in the area of the heater. The chemical reaction of the chorines and gases from the heater exhaust can create a detrimental condition and accelerate deterioration of the heat exchanger and related components.

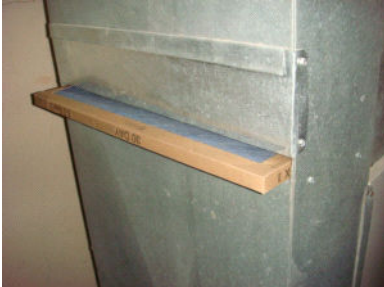
The unit was in operation at the time of the inspection and responded to the thermostat. Checking the accuracy or the calibration of the thermostat is beyond the scope of a home inspection. The general visible condition of the system is fair. All systems require replacement and/or repairs with age, between now and replacement some repairs can be expected.

There was adequate clearance around the heater. Nothing should be stored in the area of the heater. Failure to maintain this clearance can create a dangerous condition.

The heater is vented to the chimney through a metal stack. The stack appears to be in satisfactory condition at this time. It is recommended that the vent pipe from any fossil burning appliances and or heaters be mechanically fastened so as to reduce the chance of accidental separation. ***In the event of separation carbon monoxide, a colorless and odorless deadly gas may be discharged into the home.***

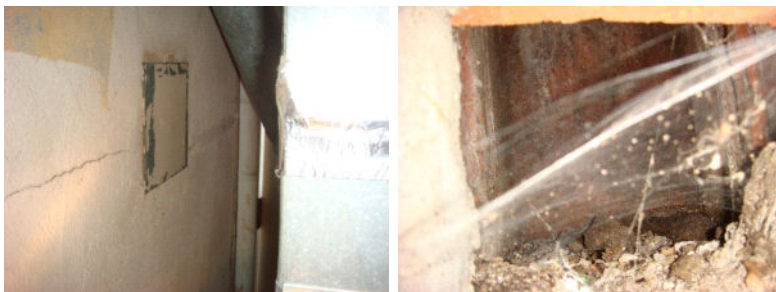
Considering the age and location of the chimney, on an outside wall with three exposed surfaces, a chimney liner maybe required when a new heater is installed or possible before. New safety standards recommend a liner for chimney installed in this manner to reduce the chance of failure of older type chimneys. Signs of past repairs and current deterioration of

ESTIMATED COST \$ The brick chimney is in need of repairs at this time. All repairs should be done by a licensed contractor.

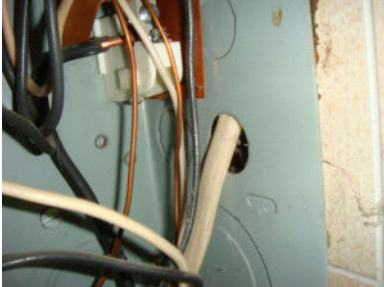
The water meter does not have a properly installed jumper for the electrical system. This should be installed so that if at any time the water meter is removed the electrical system will still be properly grounded.

ESTIMATED COST \$25.00-35.00 Install proper jumper for water meter, this must be a minimum of a #6 bare copper wire with proper clamps. If necessary a ground rod should also be installed at an added cost of \$75.00-100.00. Today a ground rod is required for all systems in addition to the water pipe ground.
