INSPECTION REPORT

**6789 Marlton Ave
Bala Cynwyd PA 19000
PREPARED BY
INSPECTIONS UNLIMITED INC.**

June 25, 2010

On April 10, 2010, I inspected the above referenced property, as per your request. The home is a 110 ± year old building. The temperature was approximately 75± degrees and the weather was overcast. The following is a summary of the conditions found from a visual inspection at that time.

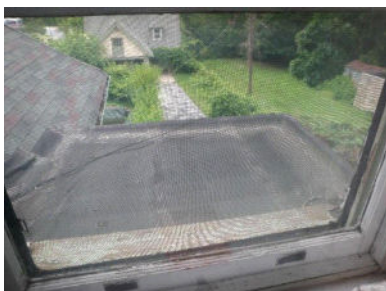
There is a small flat roof present. that covered with what is referred to as a roll roofing. This is normally a 90# mineral surface type material that is applied cold and the seams are coated with roofing cement. The intended use of this material was for vertical parapet walls and roofs with a minimum pitch of 3" per foot were the manufacturer gives it a ten year life expectancy. Although not a recommended or an approved method of roofing it is often used in the Philadelphia area as a prime roof. This is typically installed on flat or low pitch roofs often with less then 1" per foot pitch. When installed in this manner it is not considered a quality roof and has a useful life of 5± years, assuming it was installed in a professional and workmanship like manner. The installed roofing appears to be 5 years old and is in fair condition. When replacing a hot build up roof or a single ply-membrane roof is recommended. Either of these will give 10± years of service with normal maintenance.

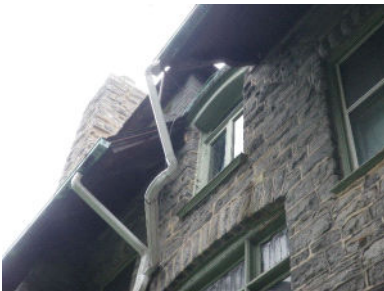
On the left side of the house there is a aluminum downspout that is loose and not properly supported. This must be repaired as necessary.

ESTIMATED COST \$150.00-250.00 Repair as necessary the gutter and downspout on the left side of the house. If replacement is necessary there will be an additional cost.

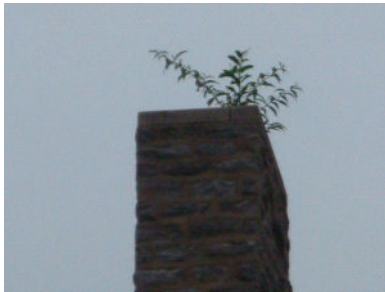
There is stone chimney installed, it appears to be in poor condition at this time when inspected from a ladder and or the ground with repairs necessary. All chimneys require ongoing maintenance and in time repairs. This is due in part to the nature of a chimney, the constant heating and cooling cycles. This will lead to deterioration and the need for repairs with eventual replacement. The presents of a "tree" growing out of the top is an indication of deterioration and reasons for concerns.

ESTIMATED COST \$125.00-175.00 The stone chimney liner is in need of an inspection to determine is it has failed. This must be performed by a qualified licensed contractor. If replacement of the chimney is necessary there will be an additional cost. The "tree" growing out of the top will have done damage to the structure and this along with the liner may require repairs or replacement.

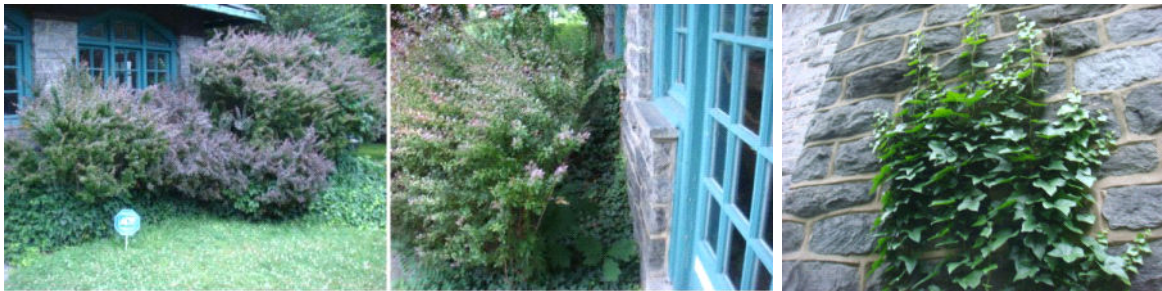
The trees and/or bushes adjacent to the building are hitting and rubbing against the building. This will in time cause wear and damage the building in any place where there is contact. We recommended that they be trimmed so as not to have direct contact with the building. This will also allow for an inspection of any hidden areas for possible damage. In areas where access was impeded no visual inspection was performed at this time. All climbing vines should be removed because they damage the areas where they attach themselves to the building. In time this will cause deterioration of the masonry joints and walls. Removal will also allow for an inspection of any hidden areas. In areas where access was impeded no visual inspection was performed at this time. Keep trees trimmed so that branches are at least 7 feet away from any exterior house surface. This will help prolong the life of your siding and roof and prevent insects from entering your home from the tree. Vines should be kept off all exterior walls, because they can help open cracks in the siding, which allows moisture or insects to enter the building.

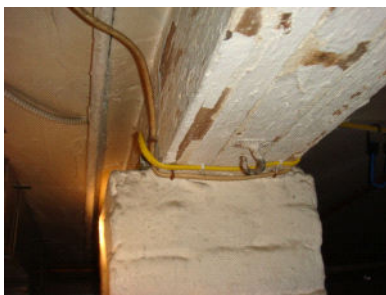
The joist, 3 x 10 set 16" o.c. (on center), were visible for 5% or less than of the accessible area,

Additional structural components consist of triple wood beams. The beams in the visible areas are supported by 4" lolly columns foundation walls brick piers.

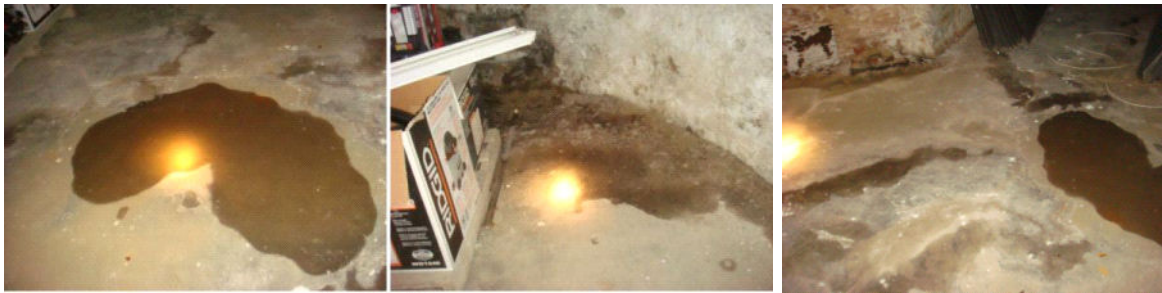
At the time of the inspection a dehumidifier was in use, these are normally used to reduce dampness in basements. It is recommended that in the future the use be continued. Dehumidifiers are normally rated by the amount of water removed per day, the higher the better. If possible the unit should be set up to drain into a sink or other point to reduce risk of overflowing from units that require manual dumping of the water.

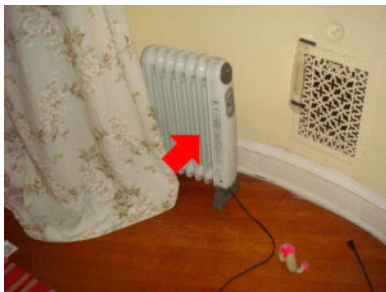
A clean out for the chimney was present and was visible inspected from the basement. No visible signs of major defects were noted at this time. As with all liners water infiltration will in time cause deterioration and the need for repairs or replacement. It is important that periodic inspections be performed to determine the conditions of the liner and a need for repairs when necessary.

There are free standing electric heaters present in some areas. This is normally an indication that the installed system is inadequate for these areas requiring additional heat.

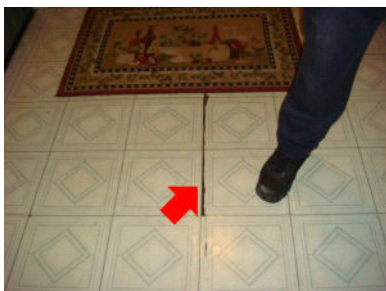
The wood cabinets are in fair to poor condition for their age. Future replacement should be considered.

The overall condition of the kitchen floor is poor for its age. It is recommended that you budget for replacement at this time. The average cost for replacement of standard floor tile is \$800.00-900.00 for up to 50 square feet and \$10.00-12.00 for each additional square foot. The floor consist of a 12 x 12 tile floor.

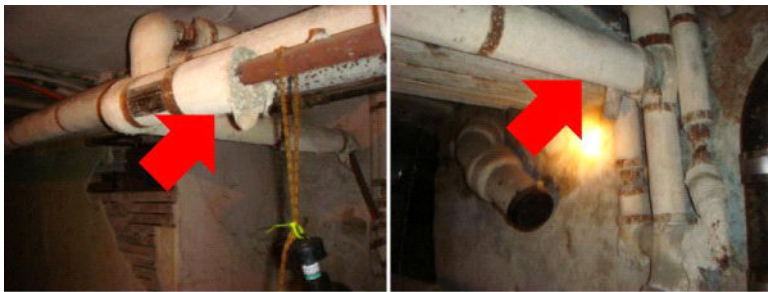
A material believed to contain asbestos, which is a known carcinogenic material, was found in the basement. The presence of asbestos should be confirmed by laboratory test. If this material is confirmed to contain asbestos and removal is necessary it should be removed by a certified company only.

ESTIMATED COST \$3500.00-4500.00 Testing by a qualified licensed contractor to determine if the material present is Asbestos Containing Material is necessary. If it is determined that the product is an Asbestos Containing Material at levels requiring removal this and any other materials found should be removed. This must be performed by a qualified licensed contractor with all necessary paper work being supplied prior to settlement documenting the removal and disposal of the Asbestos Containing Material. The cost of removal is based on a one time set up fee and an average cost of \$10.00± per lineal foot. For larger jobs over 200 lineal feet the cost per foot maybe less. These cost are assuming normal access and conditions. When adverse conditions exist the cost will be greater.

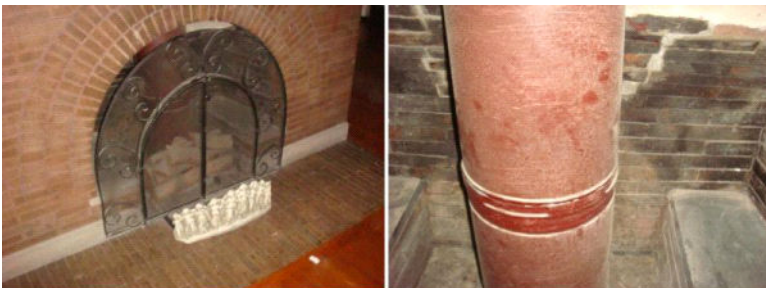
The living room fireplace has been modified and it appears the flue for the heater runs through it. Therefore it can not be used. If you are concerned about this unusual installation further evaluation is recommended.

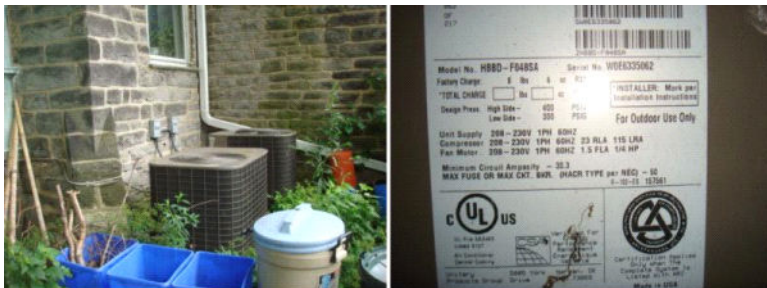
A safety disconnect switch is provided at the condensing as required for safety of service personnel.

The unit is level and free of obstructions. It is recommended that a minimum of 3' clearance be maintained around all condensing units to allow for service and proper air flow. It is important to keep this unit free of grass clipping and bushes so as to maintain proper air flow. Where necessary it is recommended that large 3-4" diameter stones be placed around the compressor for an area of 18-24". This will reduce the chances of damage caused by grass cutting.
